Eddystone Point Lighthouse Heritage Management Plan

2021

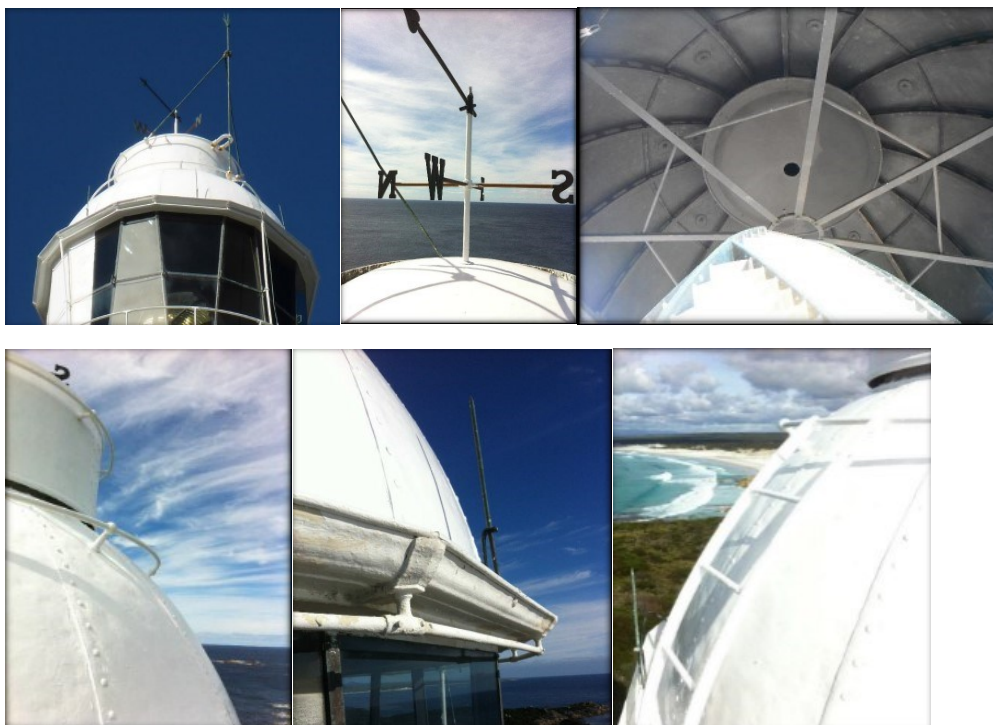
Lighthouse feature: Lantern roof

- Ribs – Chance Bros cast iron radial ribs.
- Inner skin – none (removed).
- Ventilator – drum type with wind vane and direction pointers attached. Wind vane tail broken off so not operational.
- Lightning conductor – vertical pole beside ventilator, with three spikes at top, and two braces to ventilator. Eight vertical spikes attached near the gutter.
- Drip tray – copper dish suspended under ventilator, with central hole for heat tube closed off.
- Gutter – polygonal fabricated gutter attached to ring of cast iron pieces bolted together.

Condition: intact and sound

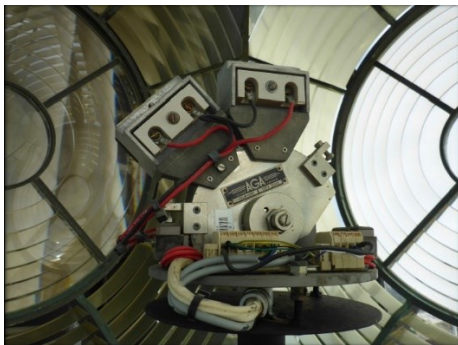
Lighthouse feature: Light source

Note: The 1st Order lens assembly have been temporarily decommissioned; replaced by a VRB- 25 beacon mounted on the handrails. The lamp was turned off due to its overwhelming contribution to the decrease in population of Short-tailed Shearwater birds in the area. The lamp caused the birds to fly into the lighthouse, damaging the Shear- water population and lighthouse.

Condition: not assessed

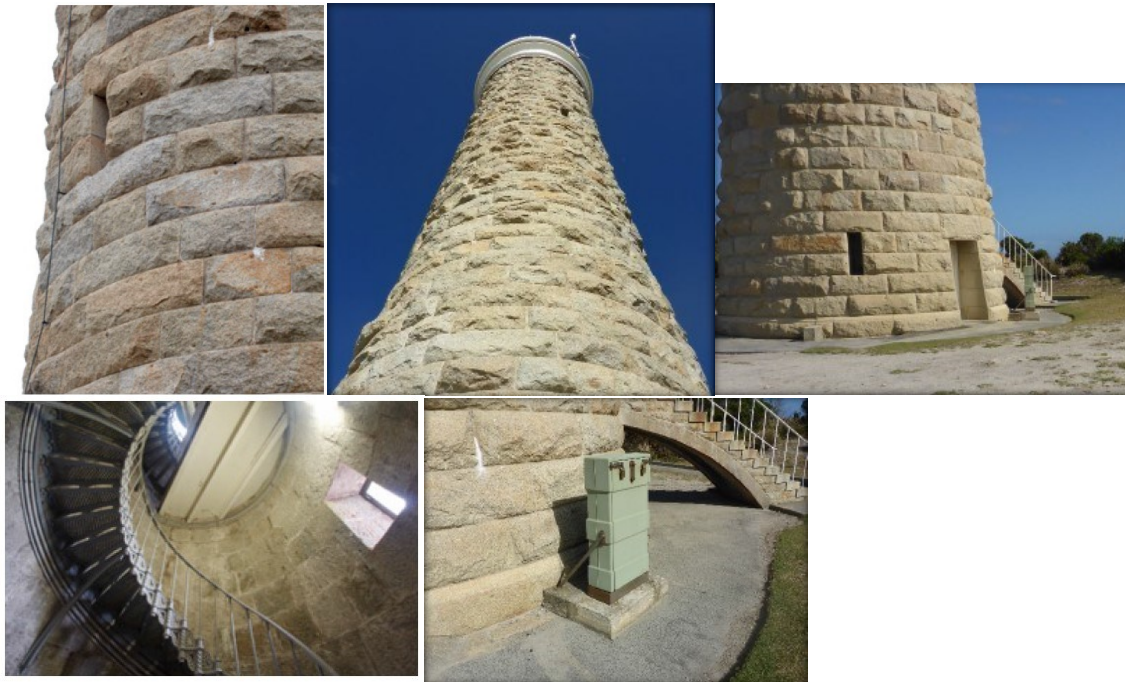
Lighthouse feature: Walls

Condition: previous evidence of water penetration through the joints but this does not appear to have caused damage to the stone external pointing has had recent repairs and some local erosion of internal pointing remains, otherwise intact and sound

As a whole, the heritage values of Eddystone Point Lighthouse demonstrate good to fair condition. All attributes of the heritage values are sound with exception of the granite tower walls which display some signs of water penetration and erosion. The heritage values of the

Maintenance: keep in service; monitor condition of pointing and stonework

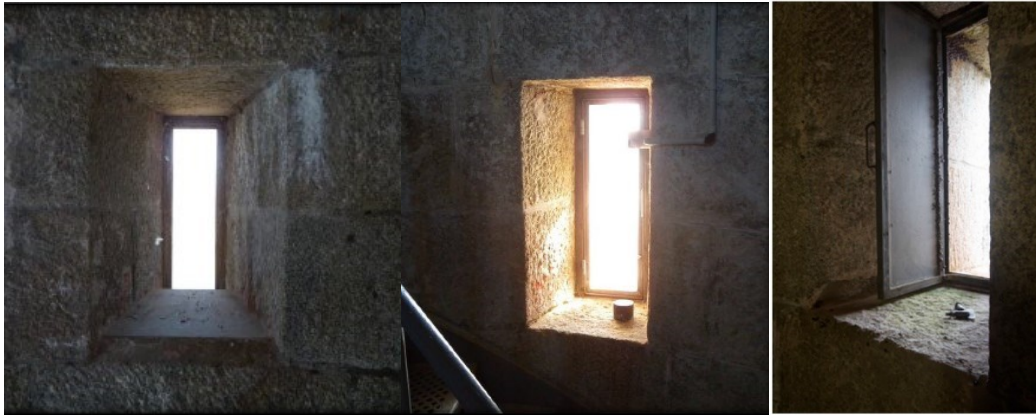
Lighthouse feature: Windows

1889 window openings with recent stainless steel frames and casement sashes.

Condition: sound

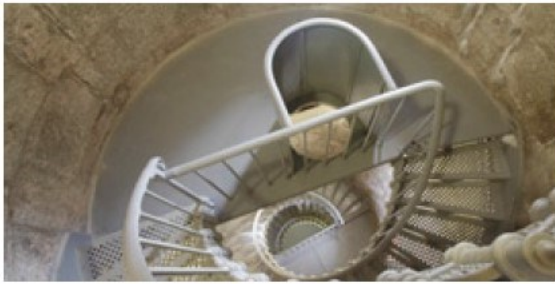
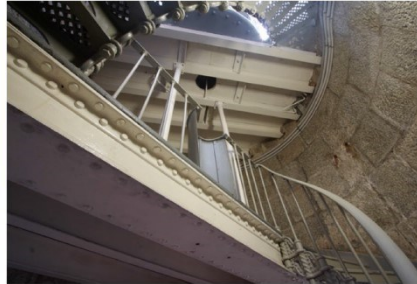
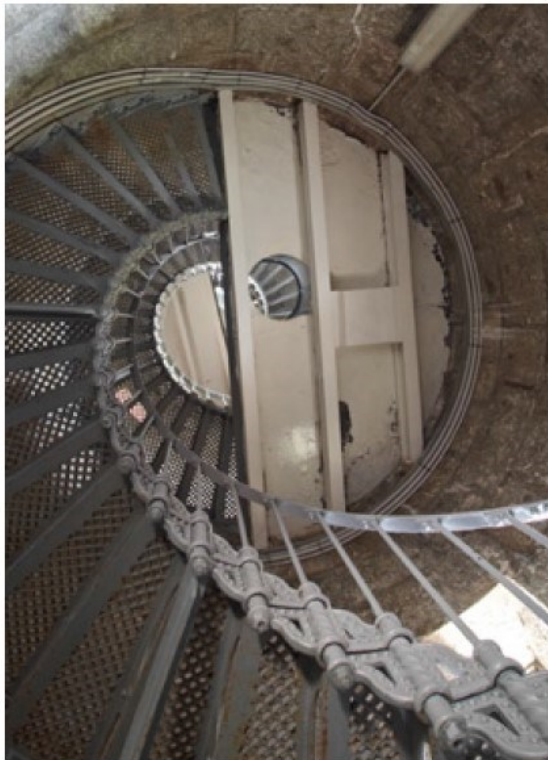
Lighthouse feature: Intermediate floors

Condition: some cracks identified in the slate slabs, otherwise intact and sound

Rectification works: detailed location and extent of cracking in slate slabs should be provided to engineer for evaluation
