Goods Island Lighthouse

Heritage Management Plan

2023

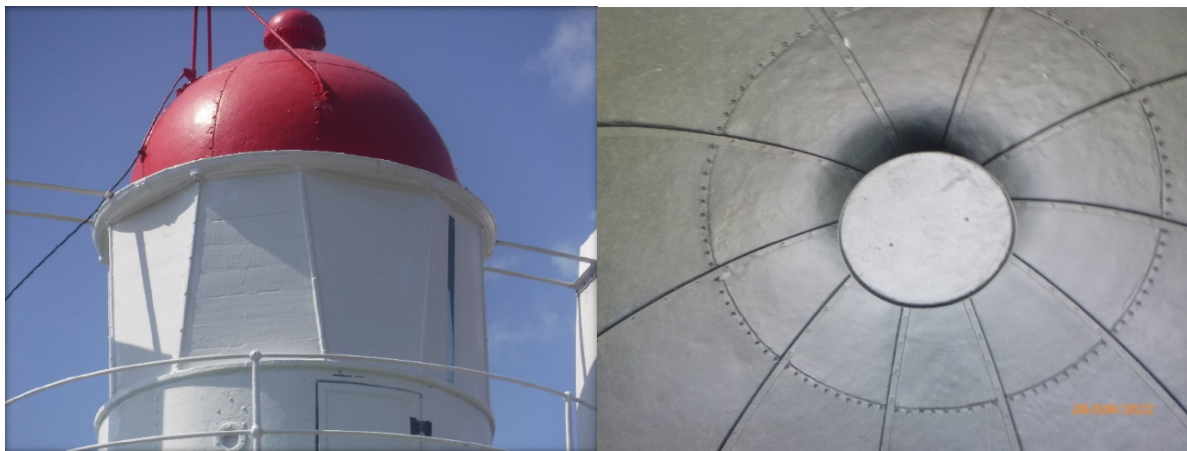
Lighthouse feature: Lantern roof

1886 Queensland Government design part-spherical dome with single skin of galvanised sheets lapped and screwed. Underwent extensive patch repairs 2021.

Finish	painted
Condition	intact and sound
Integrity	medium
Significance	high
Maintenance	keep in service, prepare and repaint at normal intervals
Rectification works	none

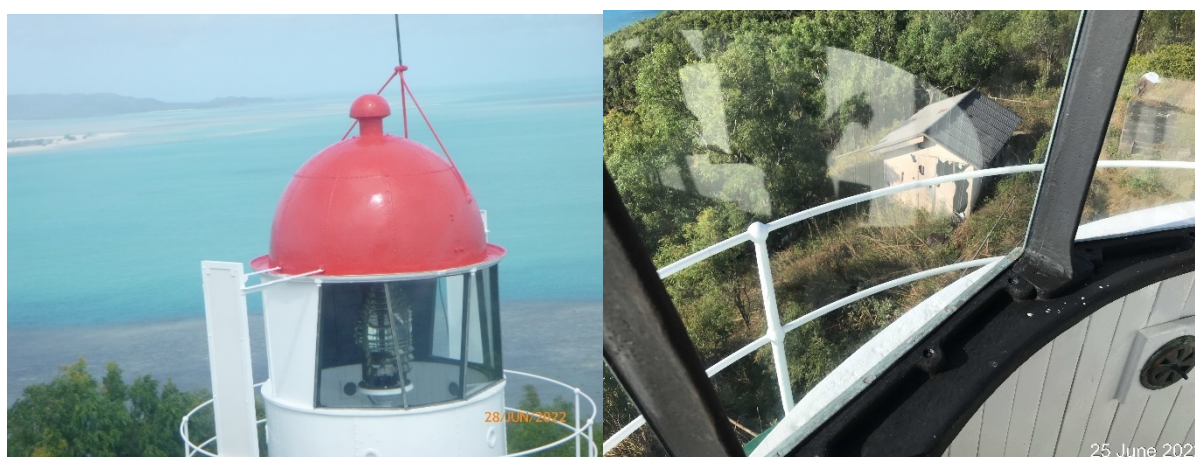
Lighthouse feature: Lantern glazing

Finish	astragals and glazing strips: painted
Condition	intact and sound
Integrity	medium
Significance	high
Maintenance	keep in service, reglaze as necessary, prepare and repaint at normal intervals
Rectification works	none

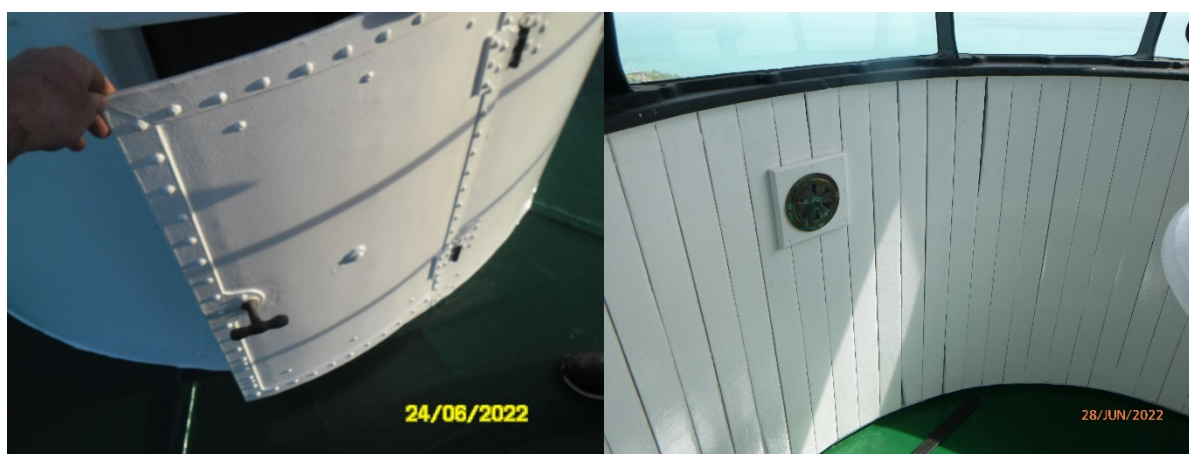
Lighthouse feature: Lantern base

Finish	painted
Condition	intact and sound
Integrity	high
Significance	high
Maintenance	keep in service, prepare and repaint at normal intervals, monitor door seal
Rectification works	none

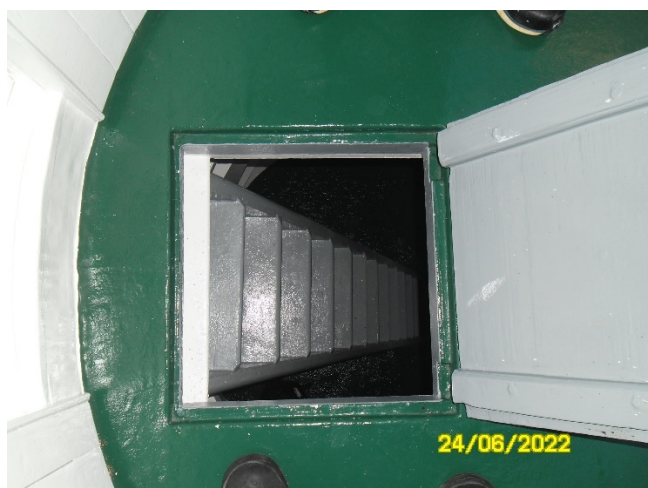
Lighthouse feature: Lantern floor

Finish	painted
Condition	intact and sound
Integrity	high
Significance	high
Maintenance	keep in service, prepare and repaint at normal intervals
Rectification works	none

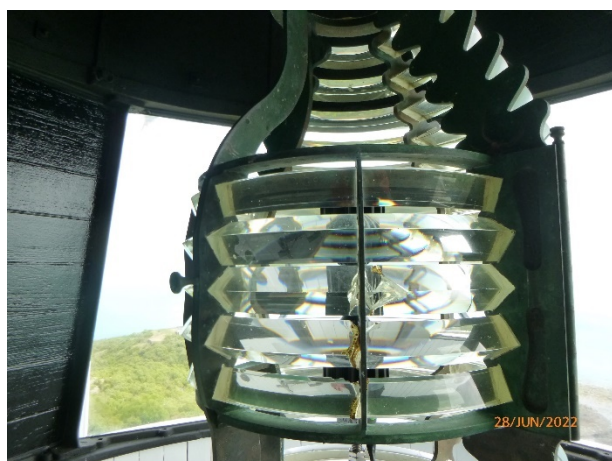
Lighthouse feature: Lens assembly

Condition	intact and sound
Integrity	high
Significance	high
Maintenance	keep in service, clean optic at normal intervals
Rectification works	none

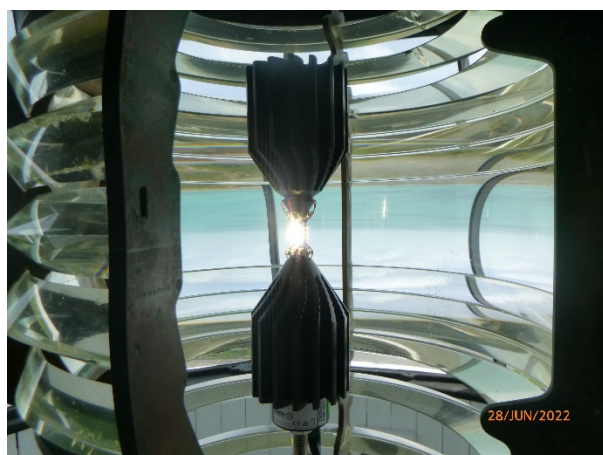
Lighthouse feature: Light source

Condition	intact and sound
Integrity	high
Significance	low
Maintenance	keep in service
Rectification works	none

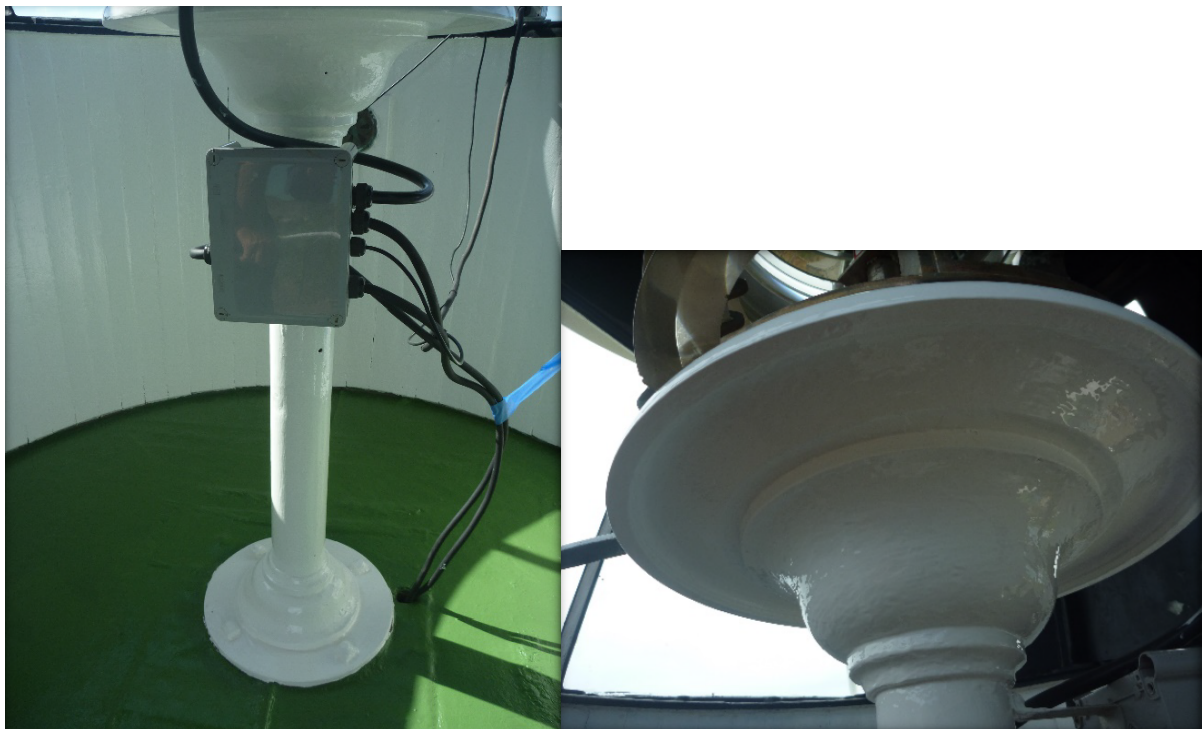
Lighthouse feature: Pedestal

Finish	painted
Condition	intact and sound
Integrity	high
Significance	high
Maintenance	keep in service, prepare and repaint pedestal at normal intervals
Rectification works	none

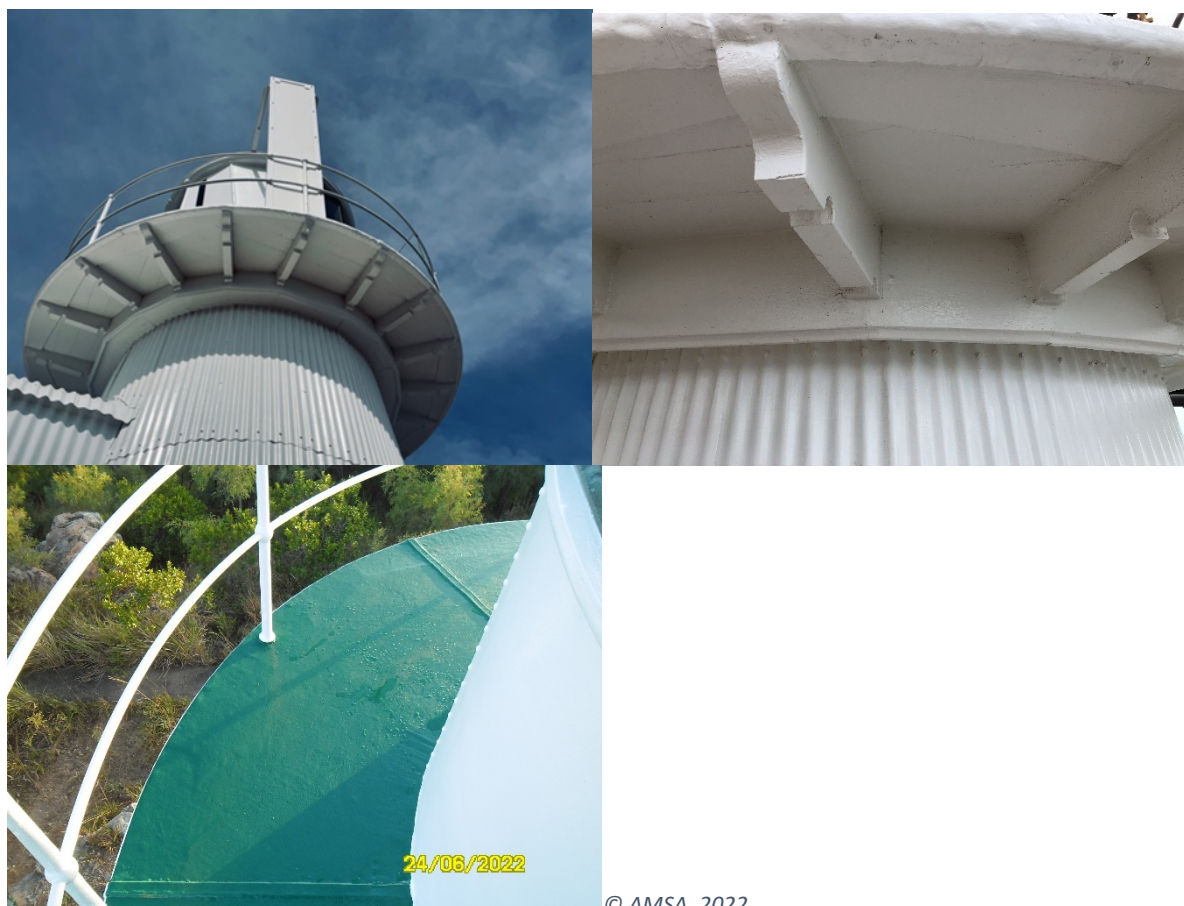
Lighthouse feature: Balcony floor

(Continuation of lantern floor) 1886 timber floor. Hardwood joists in radial arrangement. Hardwood tongue and groove floorboards. Covered with sheet lead (installed 2021), with folded lap joints.

Finish	painted
Condition	intact and sound
Integrity	high
Significance	high
Maintenance	keep in service, prepare and repaint at normal intervals, monitor condition of lead sheeting
Rectification works	none

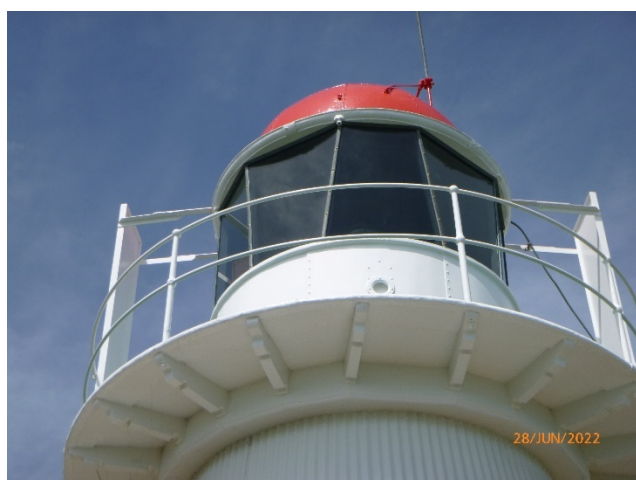
Lighthouse feature: Balcony balustrade

316 Stainless steel tube with solid wrought iron stanchions bolted to balcony floor, with wrought eyes. Round stanchion bases bolted to balcony floor. Satellite transponder fixed to top rail.

Finish	painted
Condition	intact and sound
Integrity	high
Significance	high
Maintenance	keep in service, prepare and repaint at normal intervals
Rectification works	none

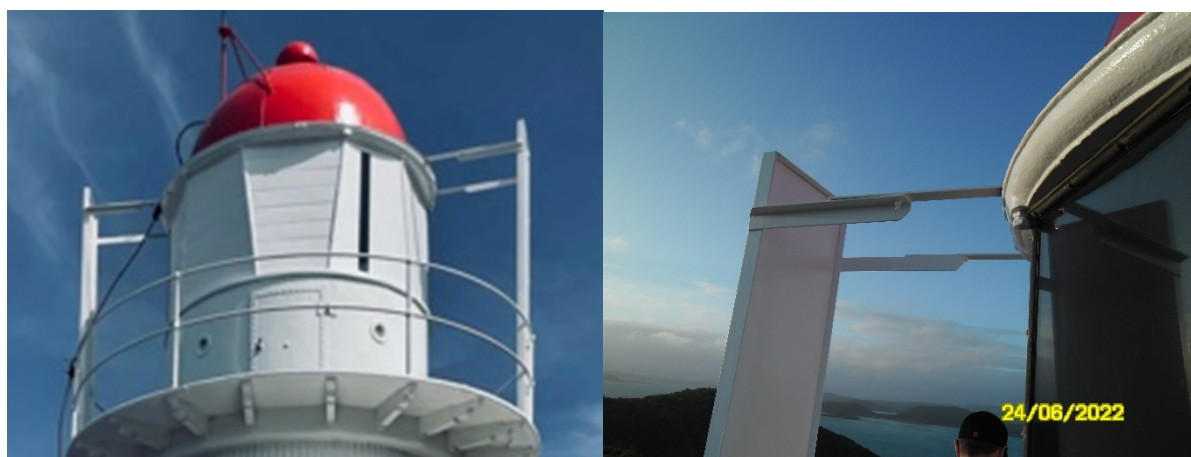
Lighthouse feature: Light screens

Finish	painted
Condition	intact and sound
Integrity	medium
Significance	moderate
Maintenance	keep in service, prepare and repaint at normal intervals
Rectification works	none

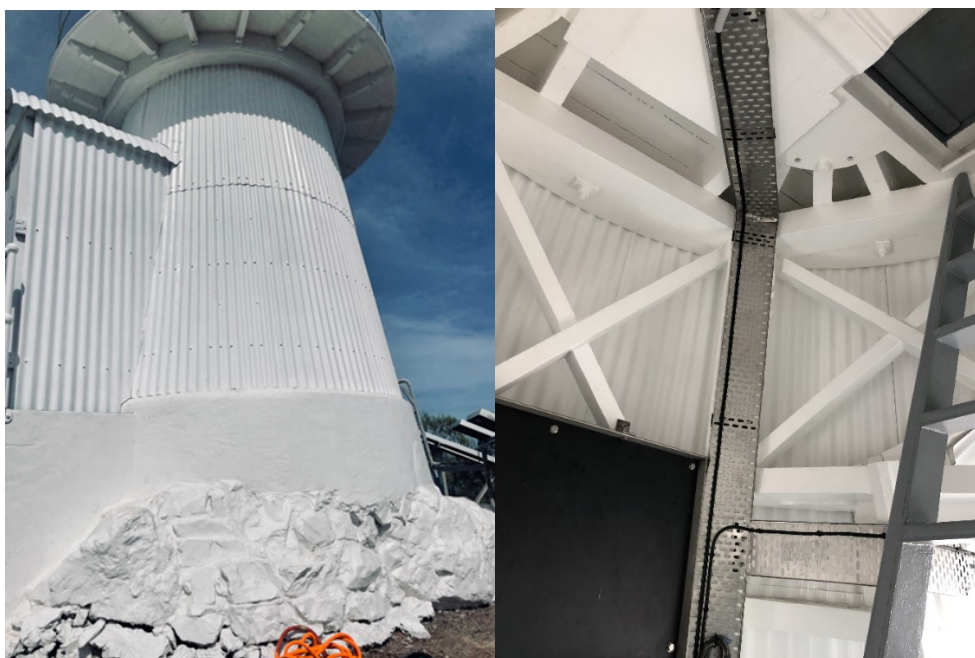
Lighthouse feature: Walls

1886 timber frame with recent corrugated 316 stainless steel cladding.

Finish	painted inside and out
Condition	intact and sound
Integrity	medium
Significance	high
Maintenance	keep in service, prepare and repaint at normal intervals, monitor condition of external cladding
Rectification works	none

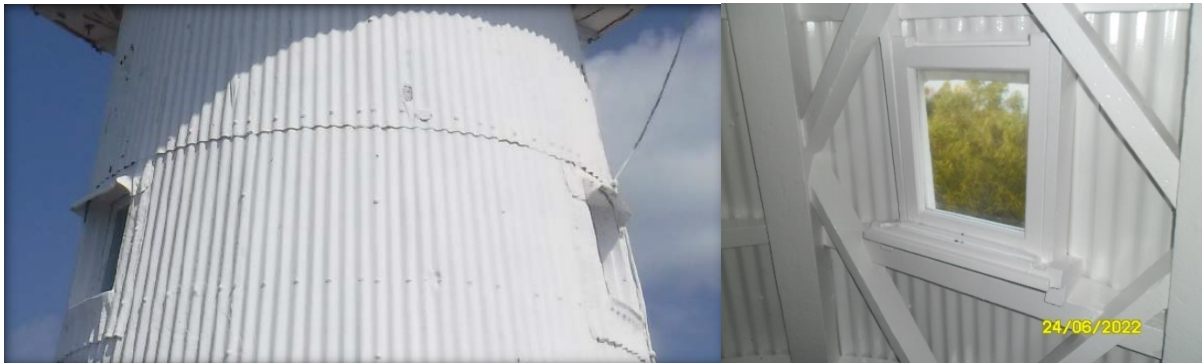
Lighthouse feature: Windows

Finish	frames, sashes and one pane: painted other pane: clear
Condition	intact and sound
Integrity	high
Significance	high
Maintenance	keep in service, prepare and repaint at normal intervals
Rectification works	none

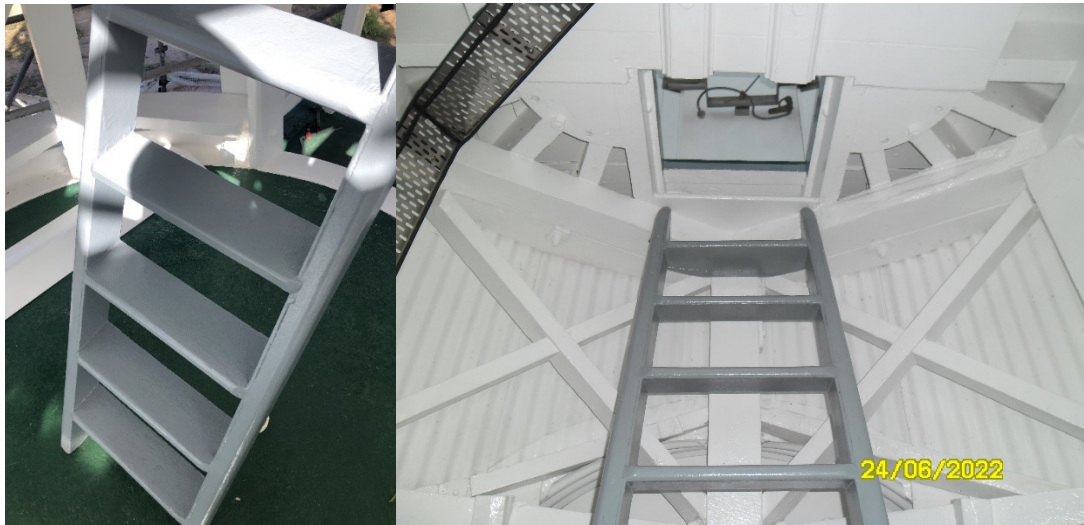
Lighthouse feature: Ladder

Finish	painted
Condition	intact and sound
Integrity	high
Significance	high
Maintenance	keep in service, prepare and repaint at normal intervals
Rectification works	none

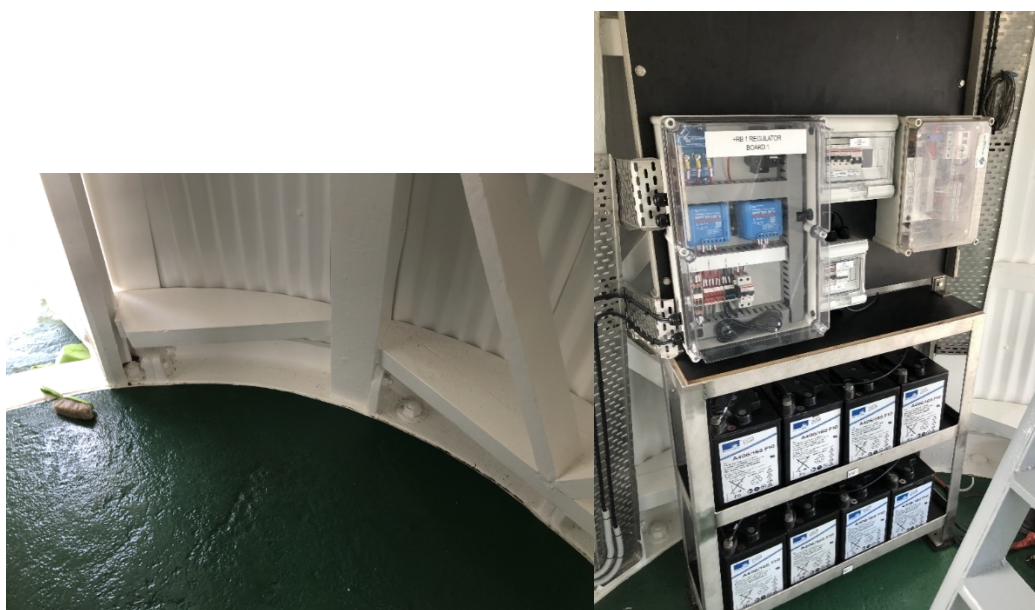
Lighthouse feature: Ground floor

Finish	painted
Condition	intact and sound
Integrity	high
Significance	high
Maintenance	keep in service, prepare and repaint at normal intervals
Rectification works	none

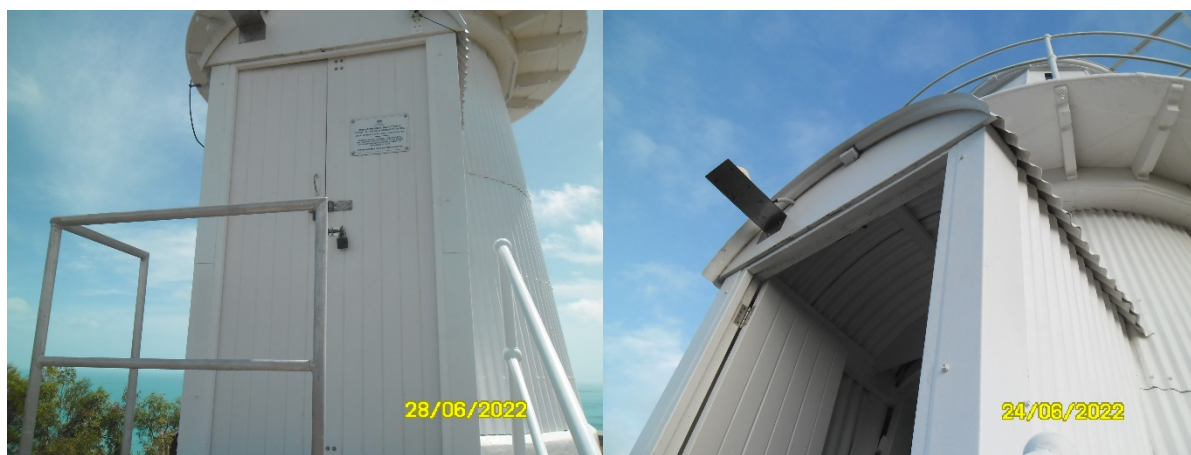
Lighthouse feature: Porch

Timber framed, corrugated iron sheeted porch, with barrel-vaulted roof. Two timber framed and sheeted external doors. Roof cladding and wall cladding of porch replaced in 2006 and 2021.

Finish	painted
Condition	corrosion at base of wall cladding, otherwise intact and sound
Integrity	high
Significance	high
Maintenance	keep in service, prepare and repaint at normal intervals
Rectification works	none

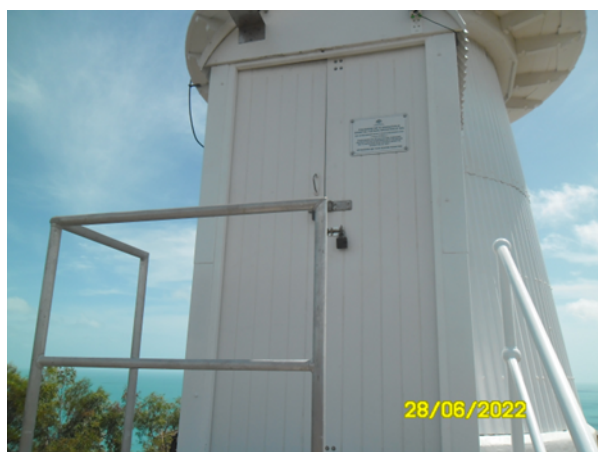
Lighthouse feature: Doors

A pair of timber framed and sheeted doors. Timber hardwood doors re-constructed 2013 as per their replacement.

Finish	painted
Condition	intact and sound
Integrity	high
Significance	high
Maintenance	keep in service, prepare and repaint at normal intervals
Rectification works	none

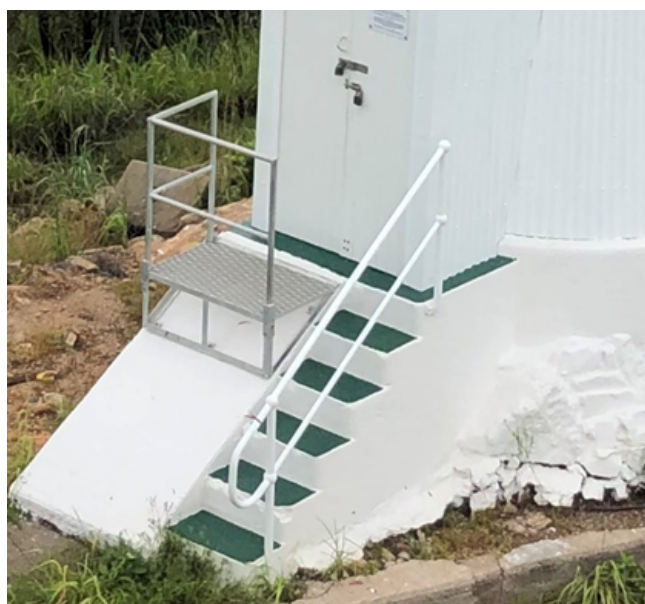
Lighthouse feature: Entry stairs

Cement rendered rubble masonry stair treads, with later concrete ramp formed over one side. Recent welded aluminium platform and balustrade attached outside the porch doorway. Stainless steel handrail installed 2021.

Finish	bare aluminium other parts painted
Condition	intact and sound
Integrity	high
Significance	aluminium and stainless steel parts: low other parts: high
Maintenance	keep in service, prepare and repaint at normal intervals
Rectification works	none

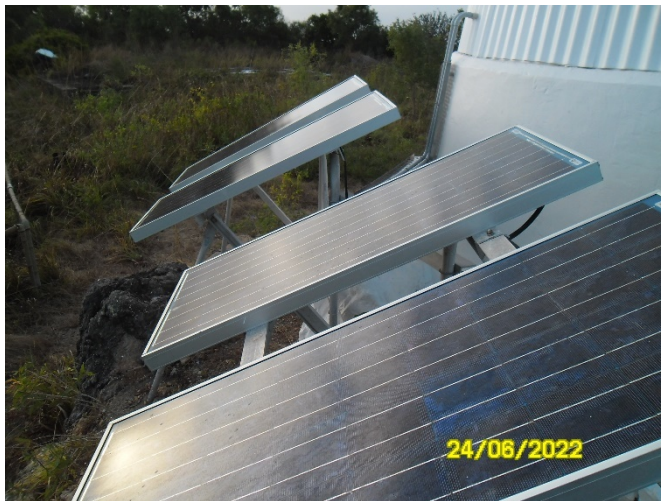
Lighthouse feature: Solar panels

Condition	intact and sound
Integrity	high
Significance	low
Maintenance	keep in service
Rectification works	none
