Tasman Island Lighthouse

Heritage Management Plan

2023

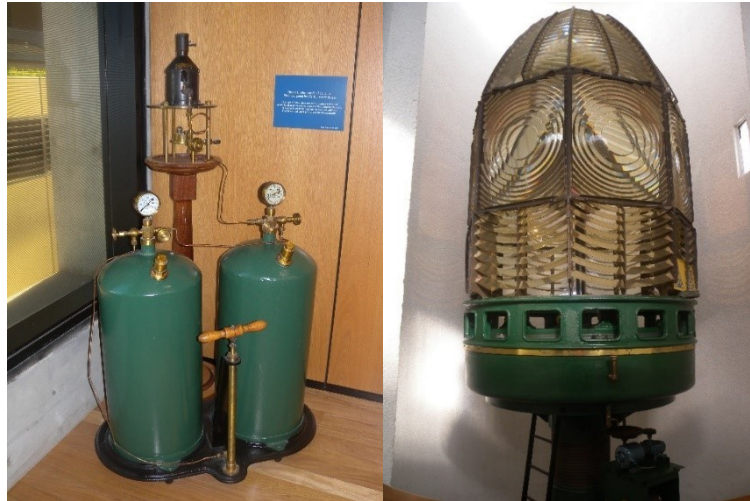
In 1900, incandescent burners were introduced. This saw the burning of fuel inside an incandescent mantle, which produced a brighter light with less fuel within a smaller volume. Light keepers were required to maintain pressure to the burner by manually pumping a handle as can be seen in Figure 8.

Figure 8. Incandescent oil vapour lamp by Chance Brothers (Source: AMSA)

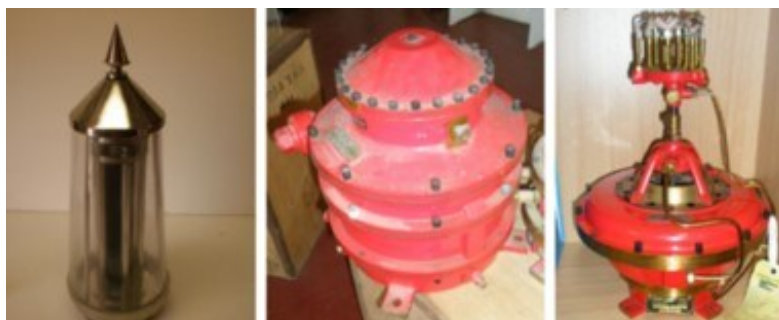
In 1912 Swedish engineer Gustaf Dalén was awarded the Nobel Prize in physics for a series of inventions relating to acetylene-powered navigation lights. Dalén's system included the sun valve, the mixer, the flasher, and the cylinder containing compressed acetylene. Due to their efficiency and reliability, Dalén's inventions led to the gradual de-staffing of lighthouses. Acetylene was quickly adopted by the Commonwealth Lighthouse Service from 1915 onwards.

Figure 10. Dalén's system - sunvalve, mixer and flasher (Source: AMSA)

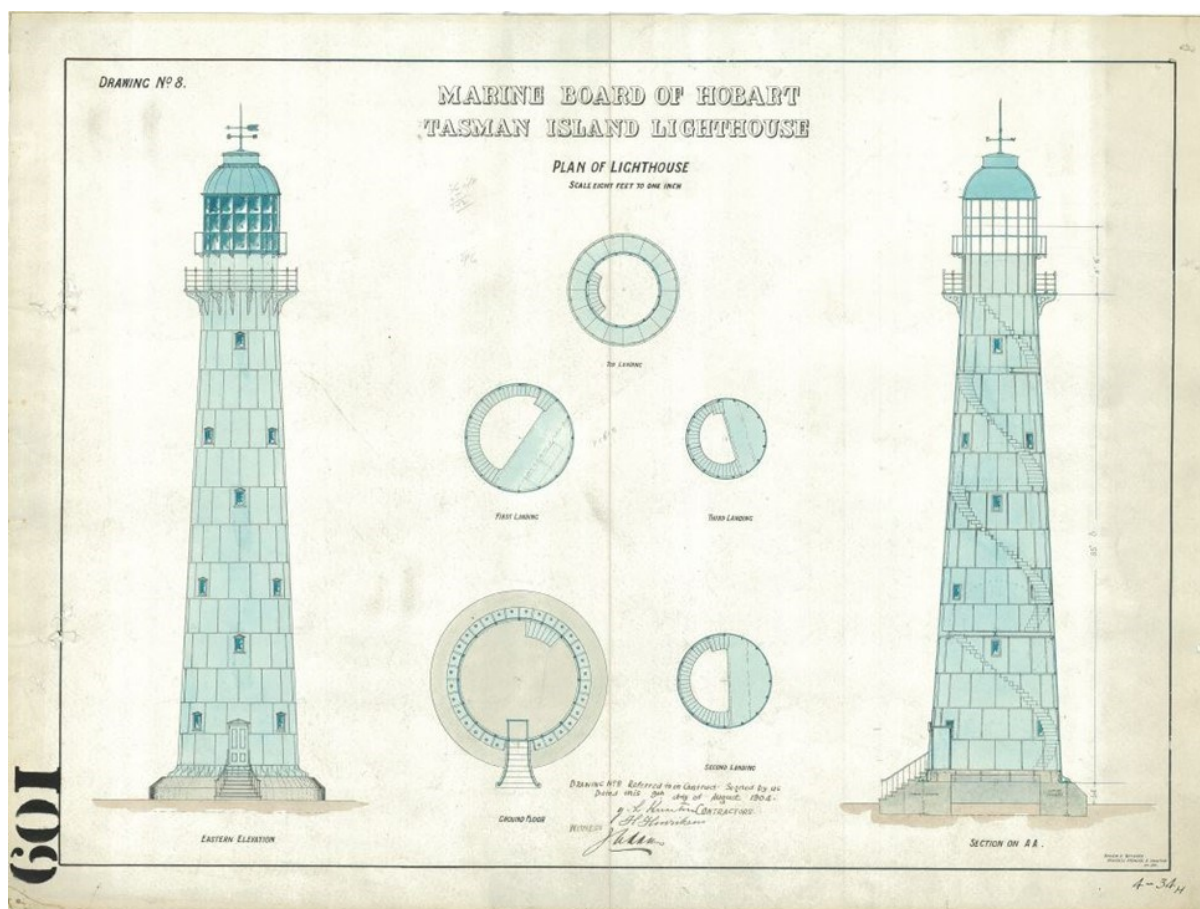
Figure 11. Marine Board of Hobart, Tasman Island Lighthouse, Huckson & Hutchison, 1904. NAA: A9568, 5/13/4. Image courtesy of the National Archives of Australia (© Commonwealth of Australia, National Archives of Australia)

Marine Board architects, Huckson and Hutchison, forwarded plans and specifications for the Tasman Island Lightstation to the Hobart Marine Board in June 1904. As per Mr Meech's instructions, it was to be a cast iron tower on cement foundations and fitted with an incandescent light²².

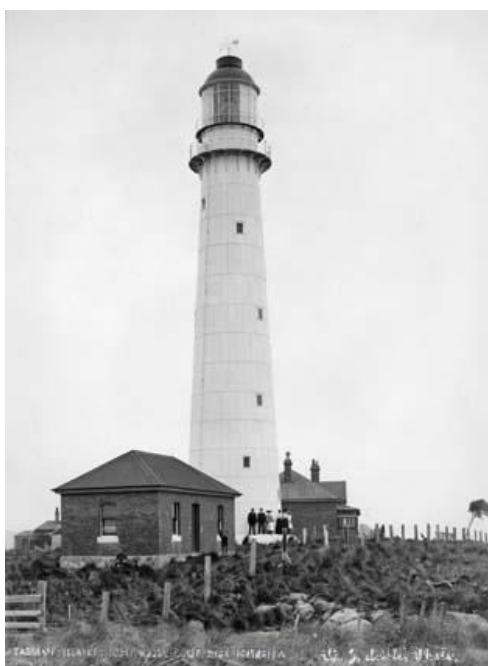
Figure 12. Tasman Island Lightstation before removal of original lantern house, 1910. Image courtesy of the NAA: A1861, 1958 (© Commonwealth of Australia, National Archives of Australia)

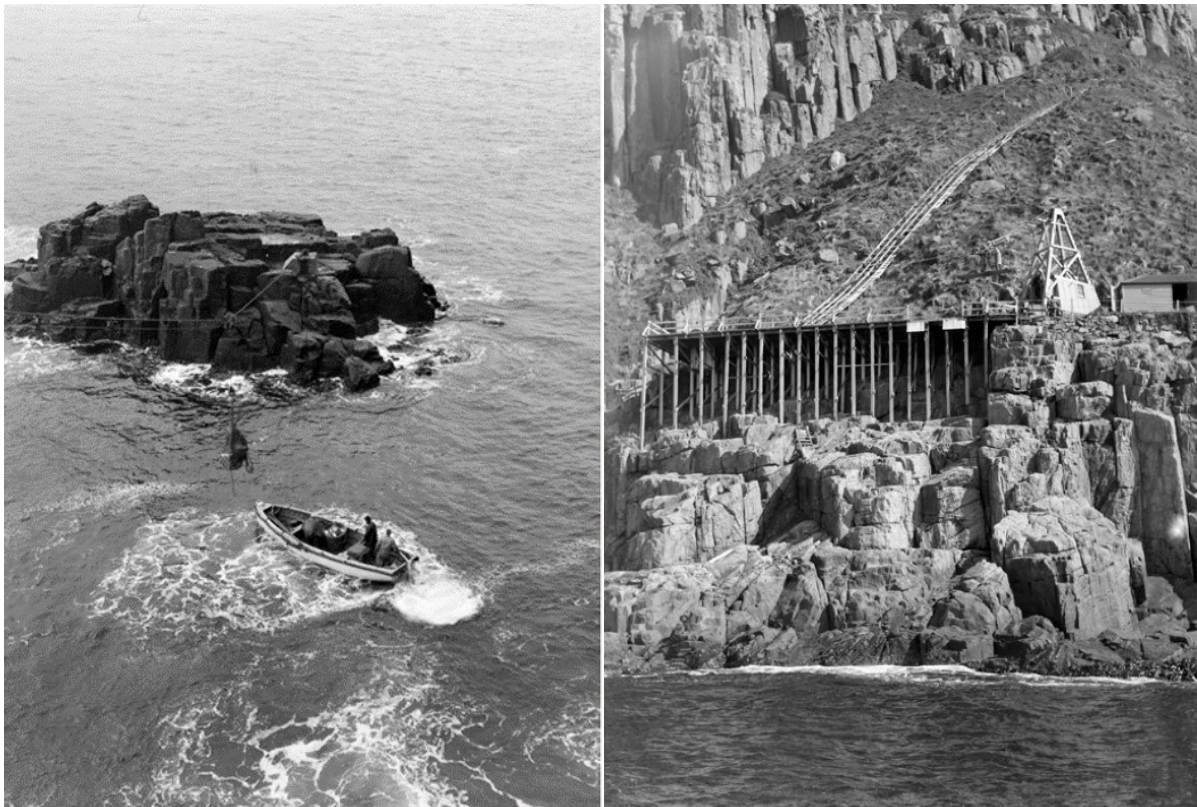
Figure 13. (Left) Tasman Island Lighthouse landing, showing the method used to unload supplies and personnel destined for the lighthouse, 1948. Image courtesy of NAA: A1200, L11284. (© Commonwealth of Australia, National Archives of Australia)

Figure 14. (Right) Lighthouse landing and incline tramway, Tasman Island, off the south-east corner of Tasmania, 1948. Image courtesy of NAA: A1200, L11285. (© Commonwealth of Australia, National Archives of Australia)

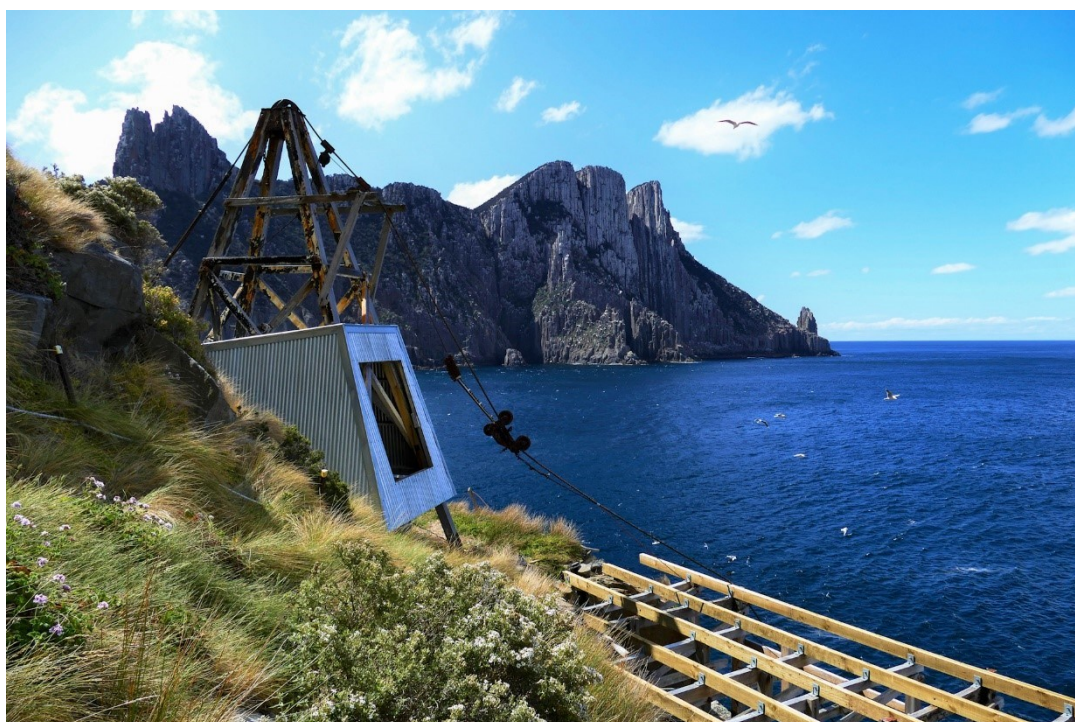
Figure 17. Winch shed at Tasman Island, reclad by Parks & Wildlife Service Tasmania (© Brett Hall, 2019)

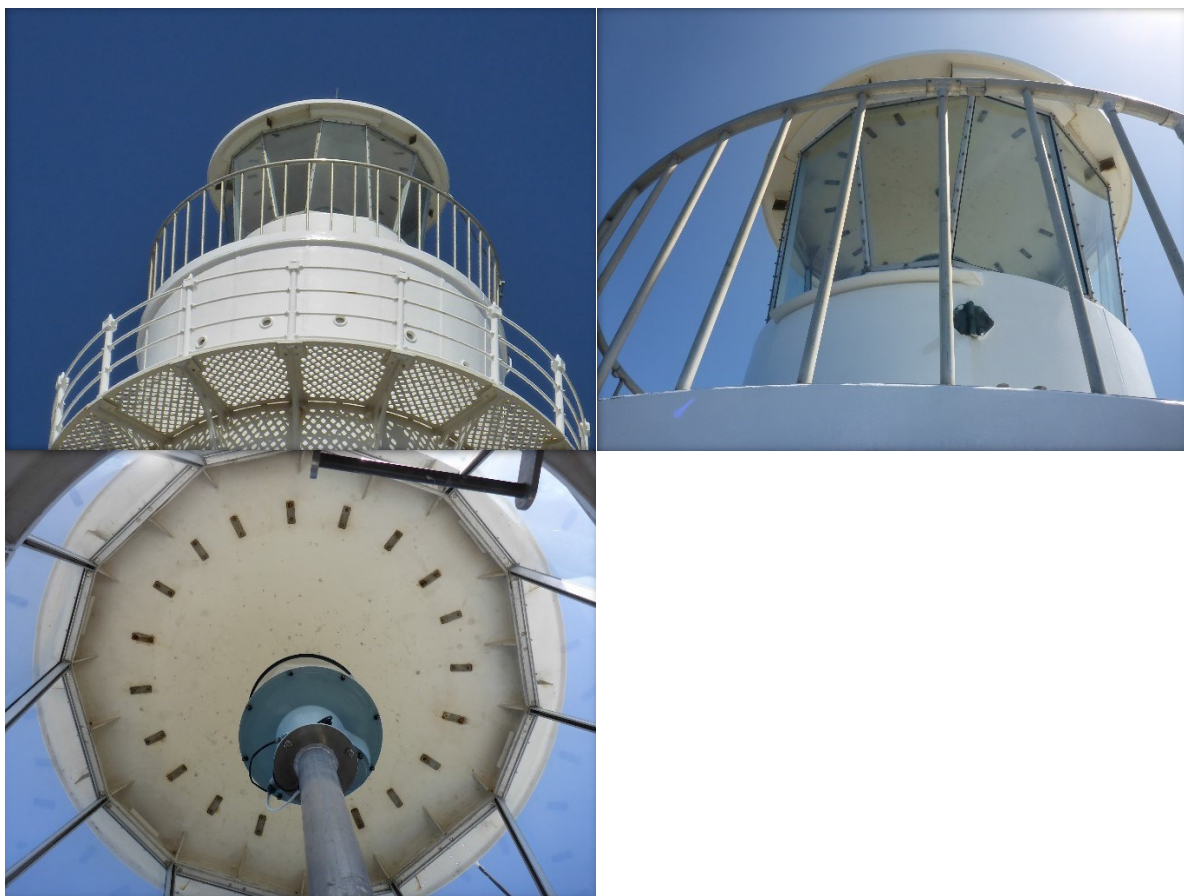
Lighthouse feature: 1976 GRP lantern on top of 1906 Chance Brothers lantern base.

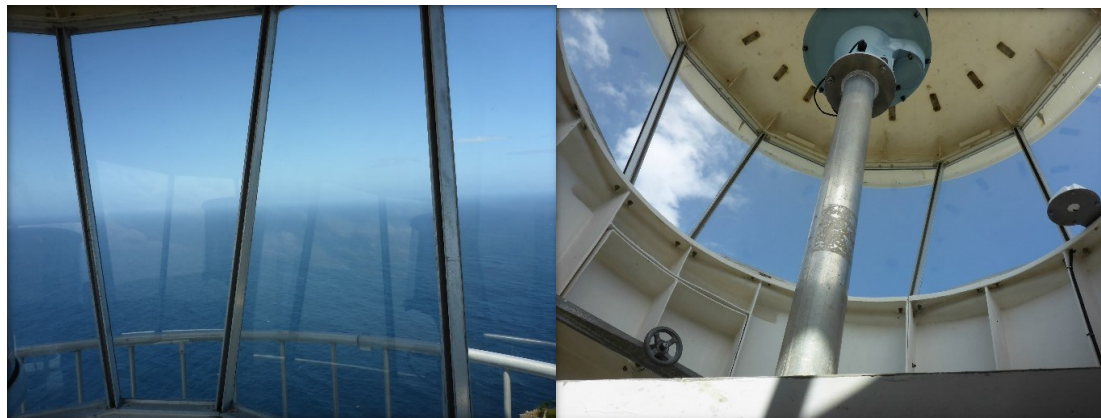
Lighthouse feature: 1976 Lantern glazing

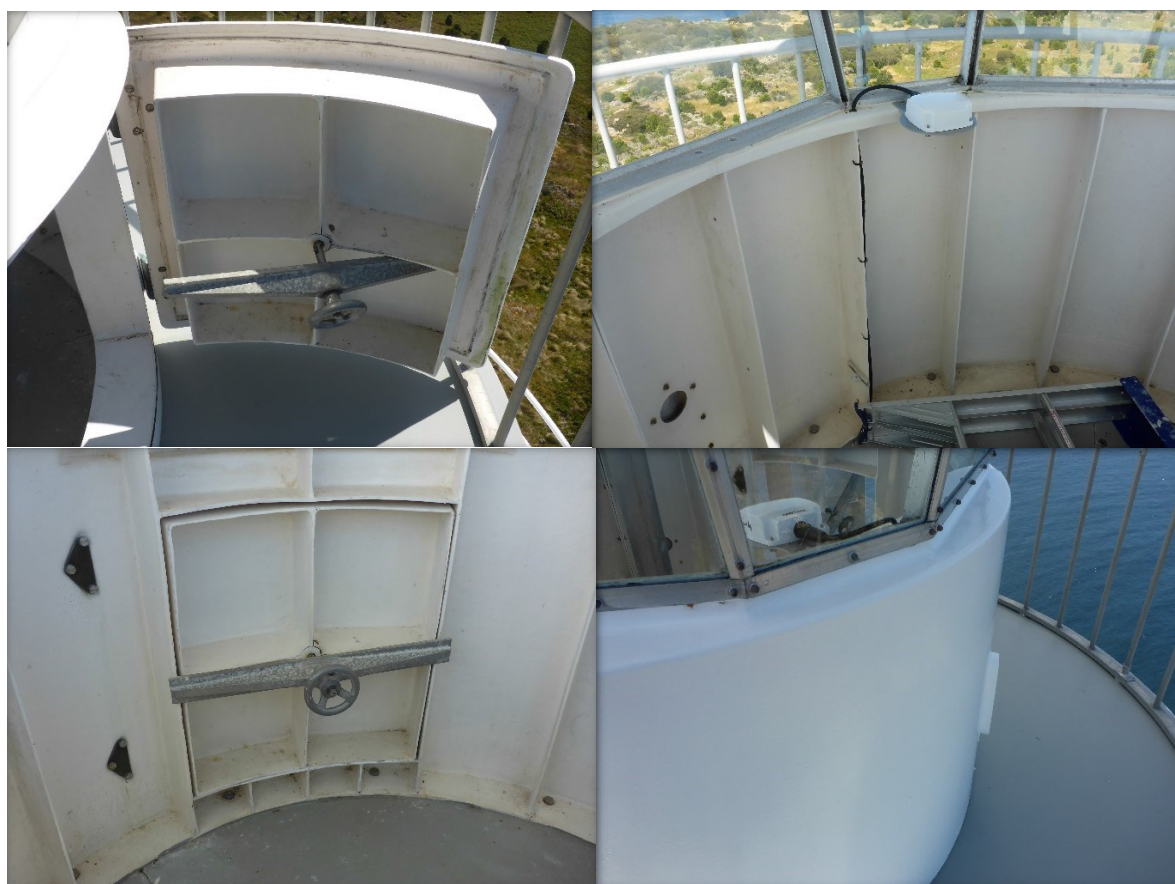
Lighthouse feature: 1976 lantern base

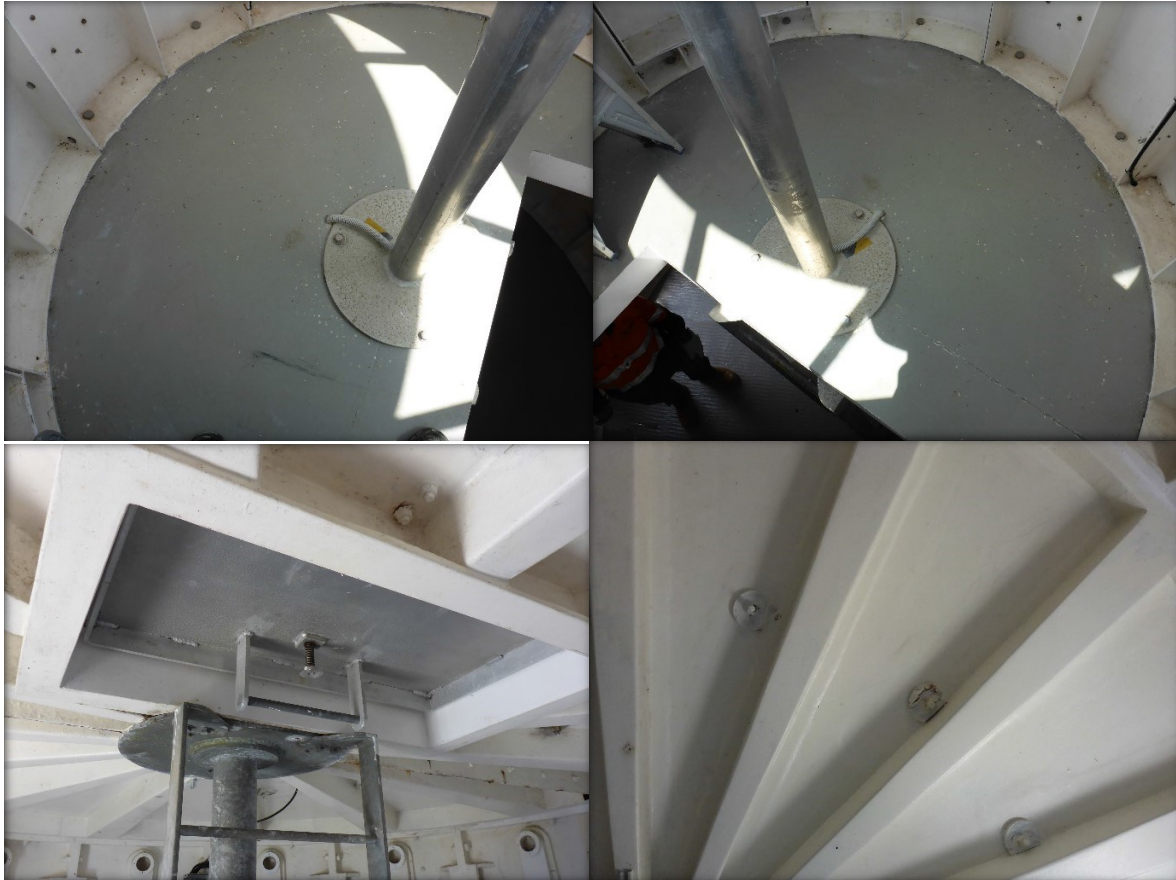
Lighthouse feature: 1976 lantern floor

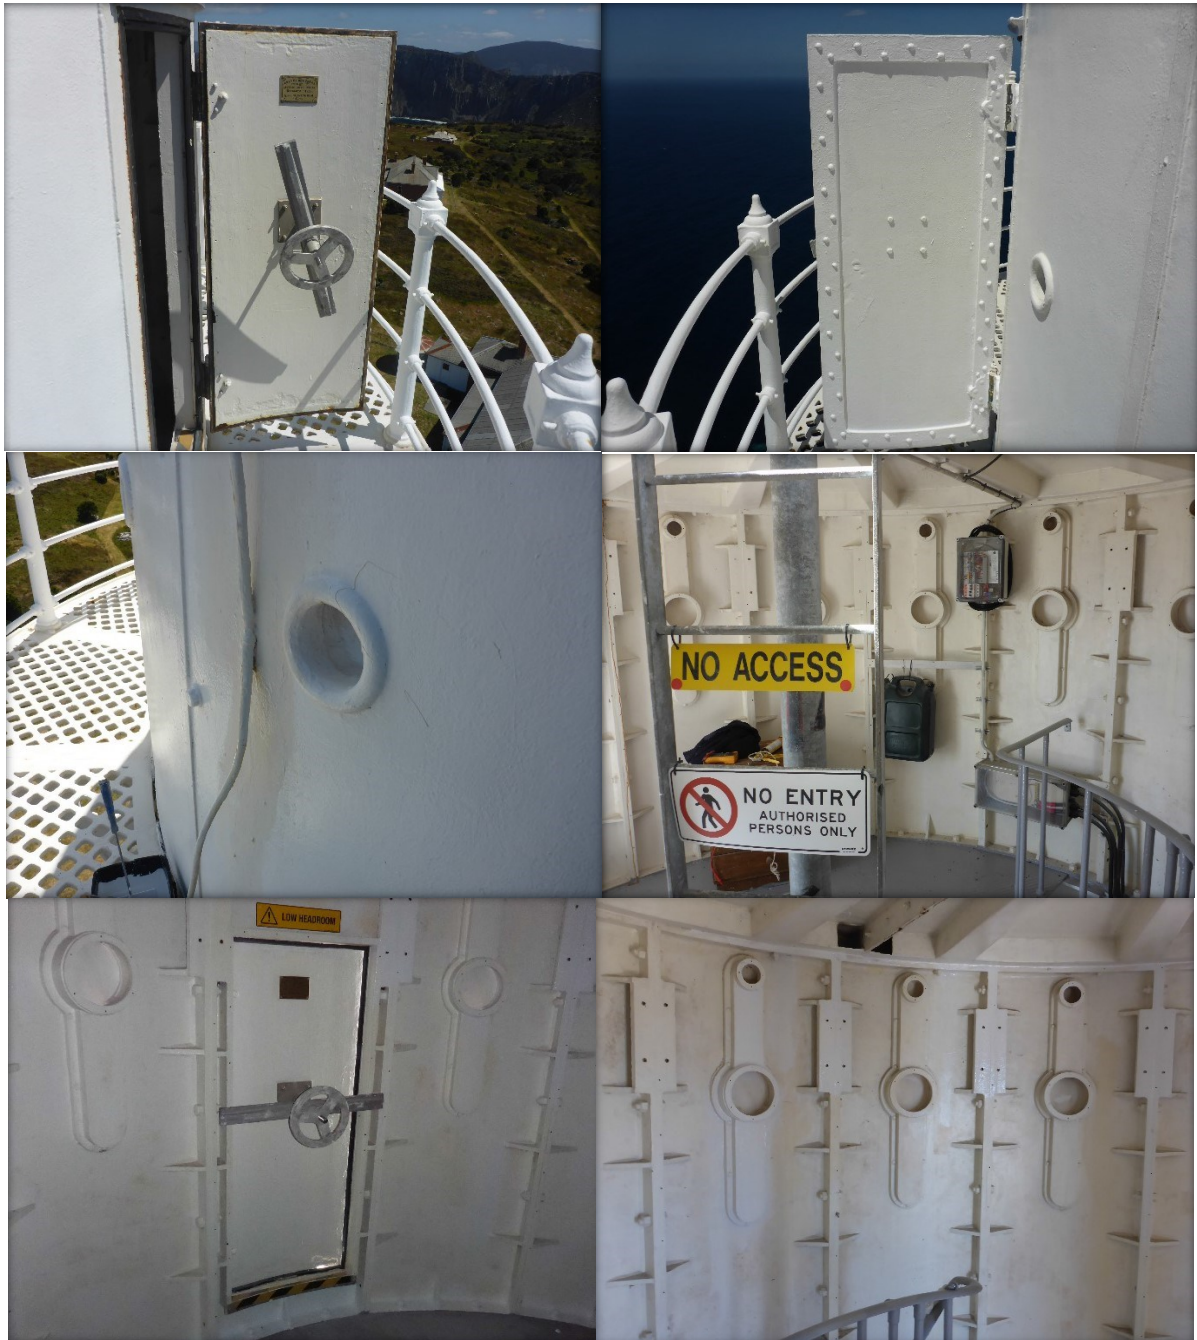
Lighthouse feature: 1906 lantern base

The 1906 lantern base contributes to the aesthetic value of the lighthouse within its setting (criterion e).

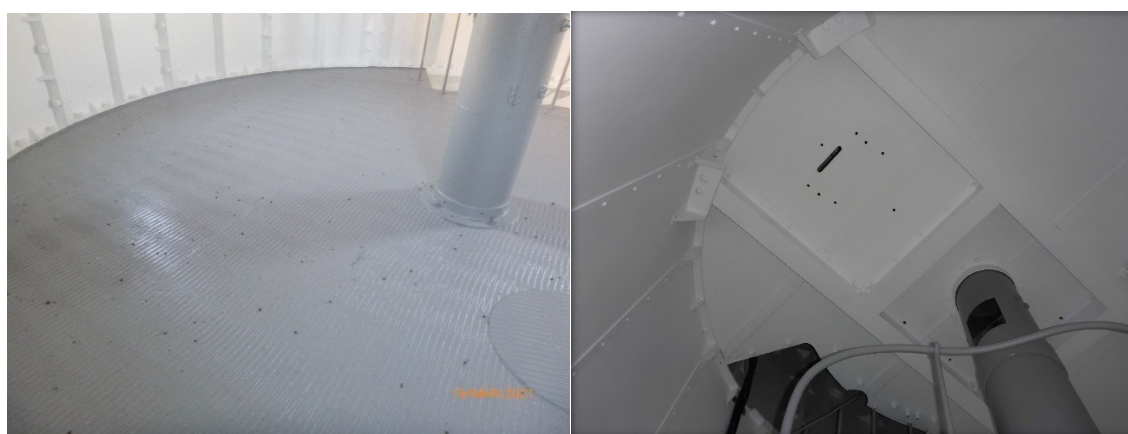
Lighthouse feature: 1906 lantern floor

The 1906 lantern floor is an original part of a relatively intact twentieth century lighthouse complex (criterion d).

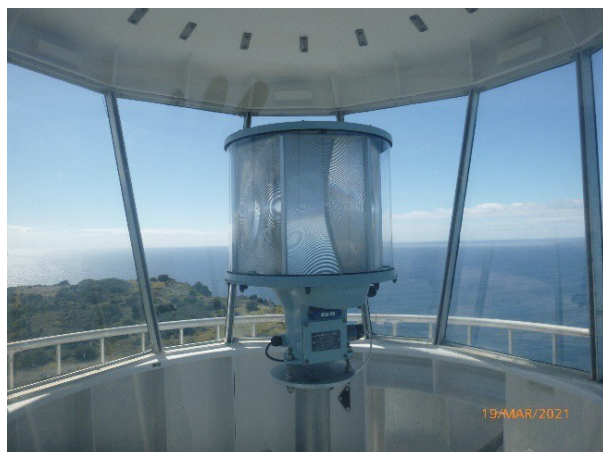
Lighthouse feature: Beacon

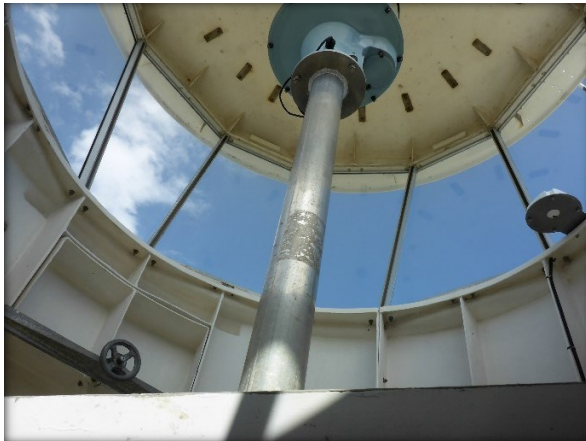
Lighthouse feature: Pedestal

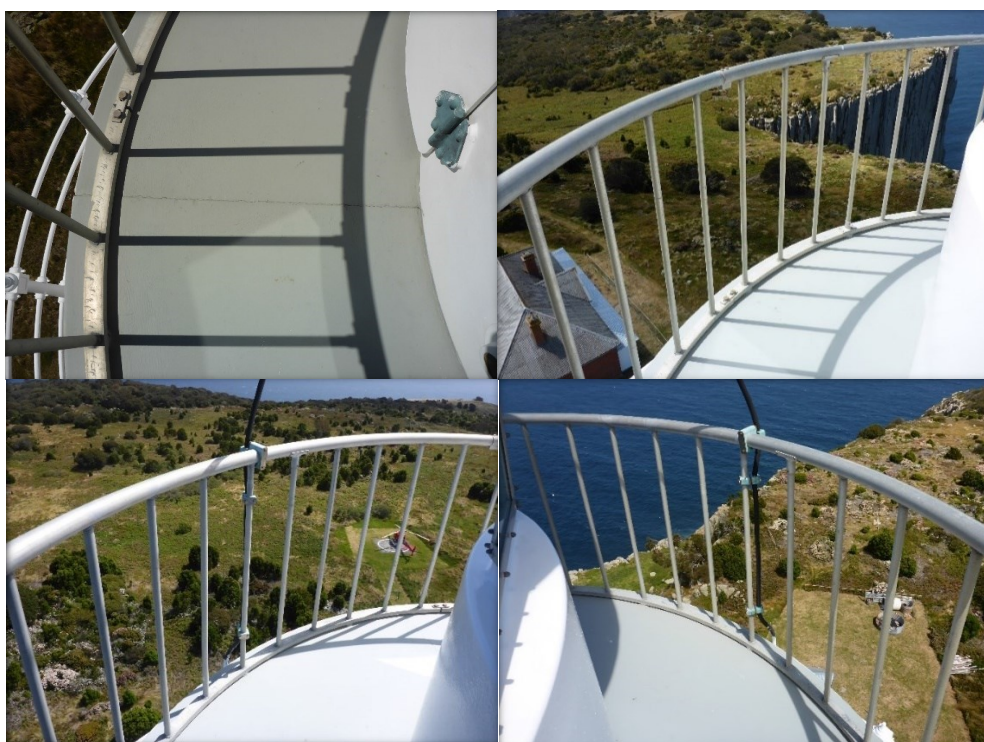
Lighthouse feature: 1976 Balcony floor – upper

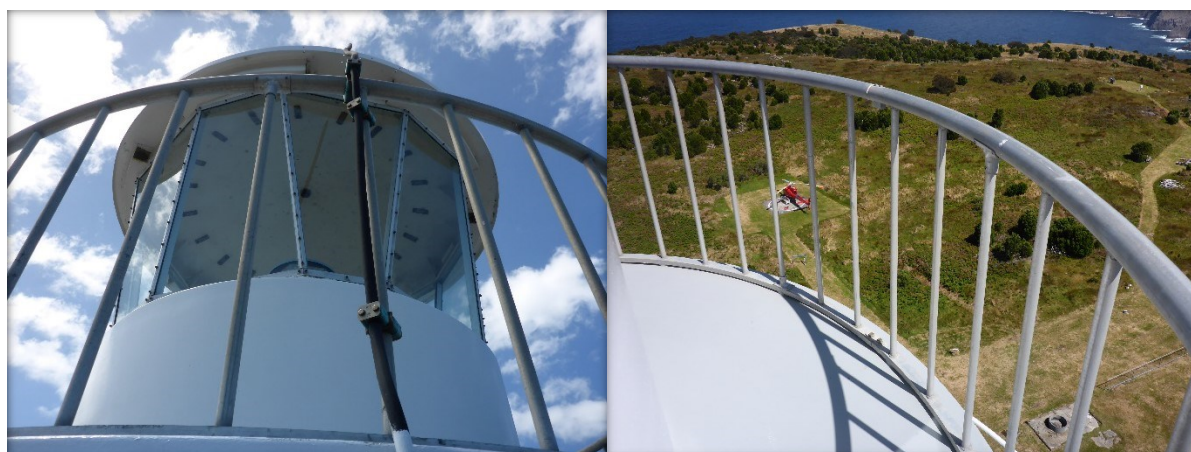
Lighthouse feature: 1976 Balcony balustrade – upper

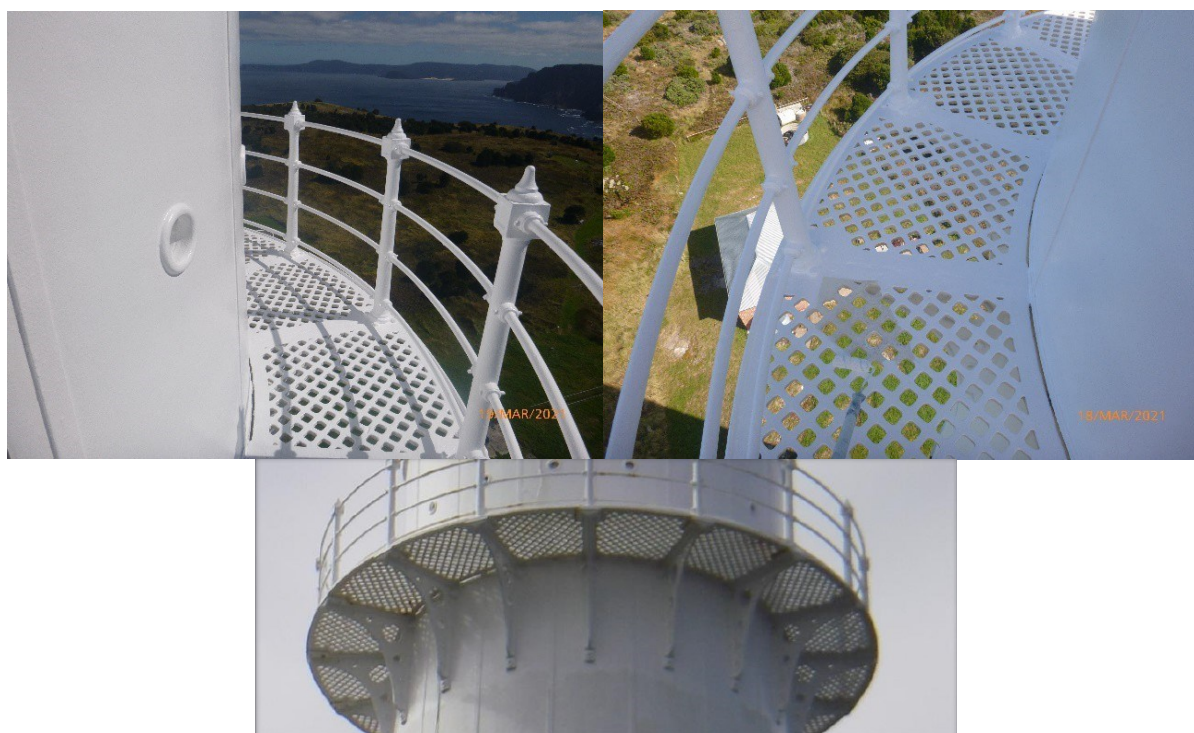
Lighthouse feature: 1906 Balcony floor – lower

The 1906 balcony floor (lower) contributes to the aesthetic value of the lighthouse within its setting (criterion e).

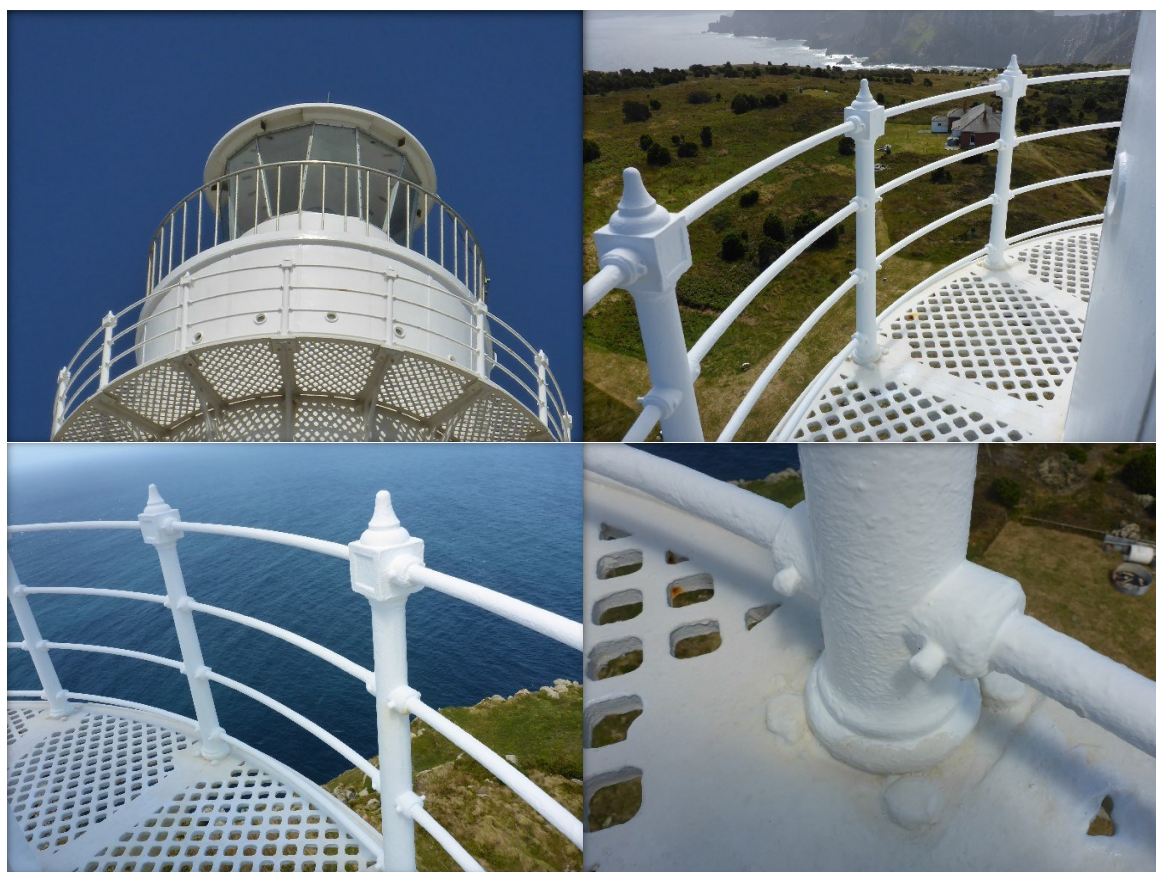
Lighthouse feature: 1906 Balcony balustrade – lower

The 1906 balcony balustrades (lower) contribute to the aesthetic value of the lighthouse within its setting (criterion e).

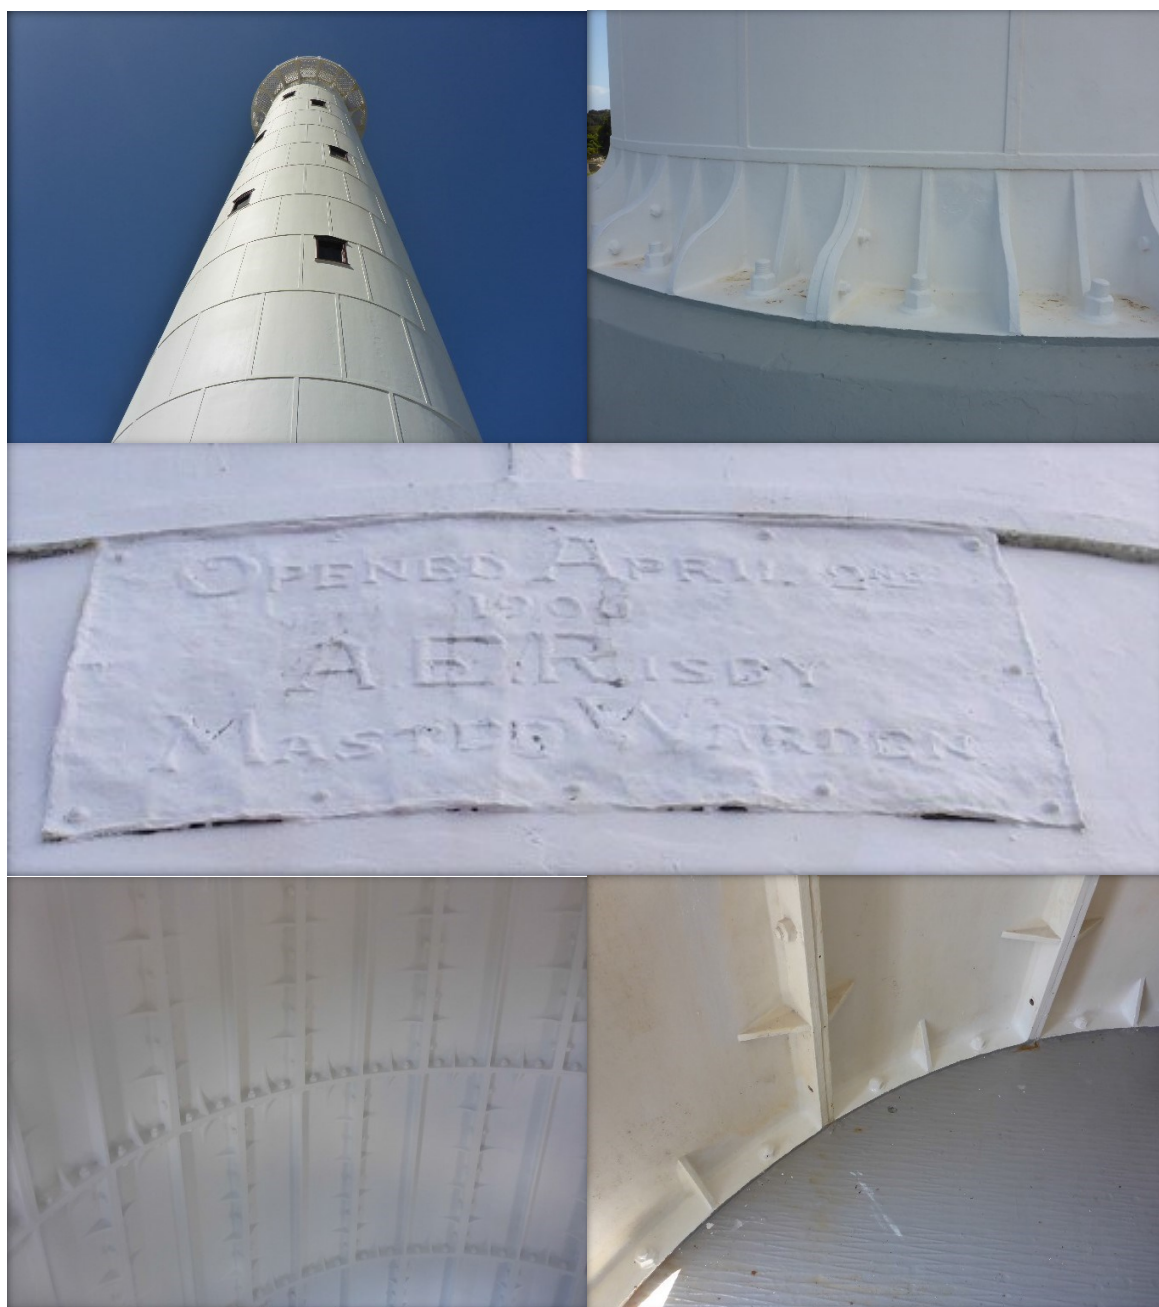
Lighthouse feature: Walls

The tower walls contribute to the aesthetic value of the lighthouse within its setting (criterion e).

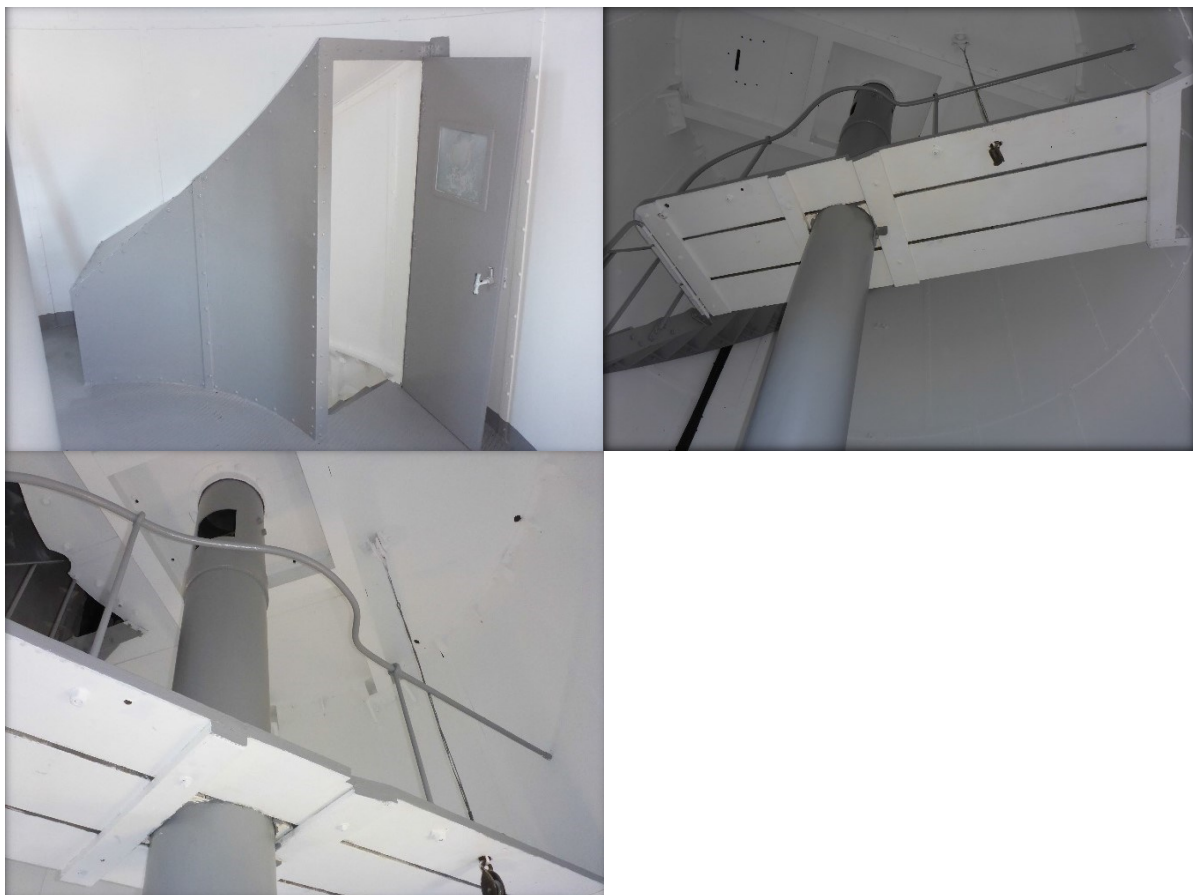
Lighthouse feature: Service room

The service room is an original part of a relatively intact twentieth century lighthouse complex (criterion d).

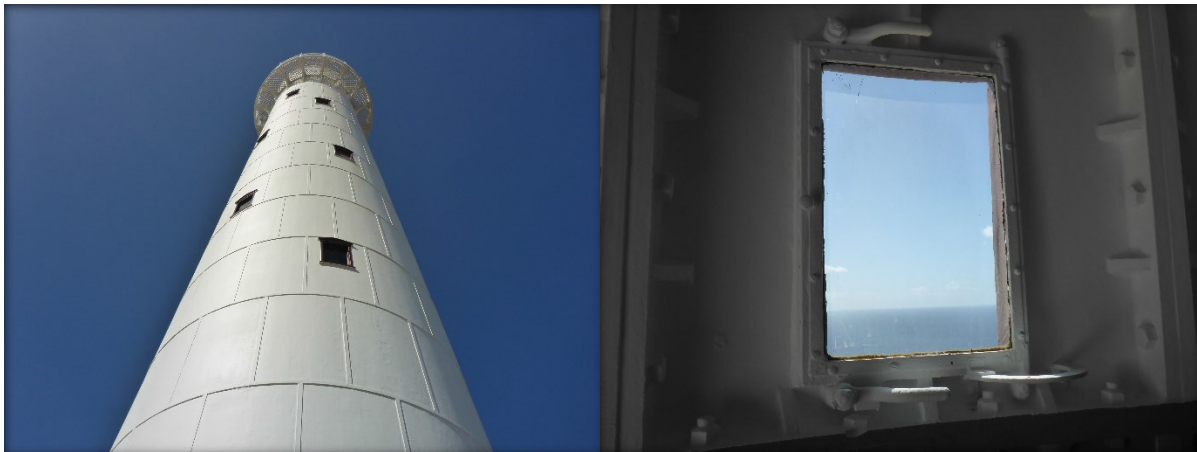
Lighthouse feature: Windows

The windows contribute to the aesthetic value of the lighthouse within its setting (criterion e).

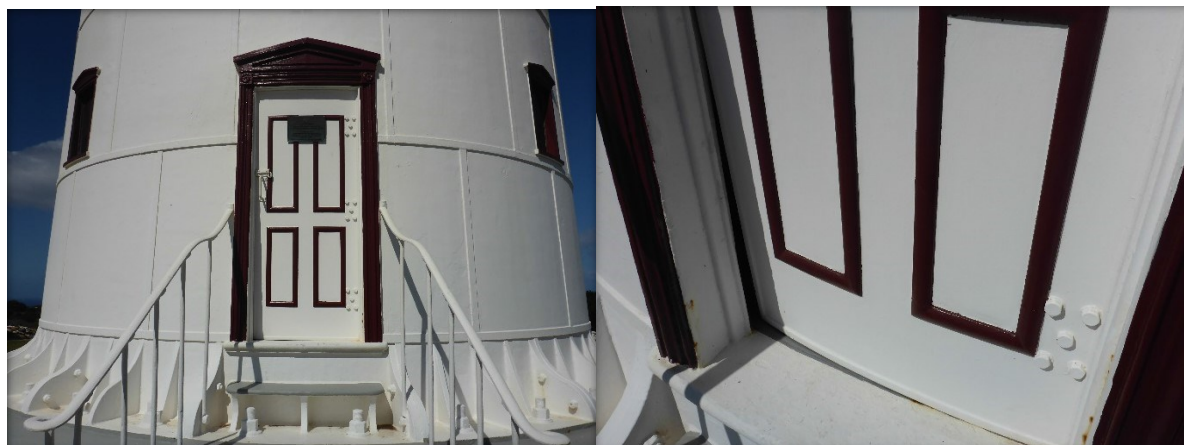
Lighthouse feature: Door

The door contributes to the aesthetic value of the lighthouse within its setting (criterion e).

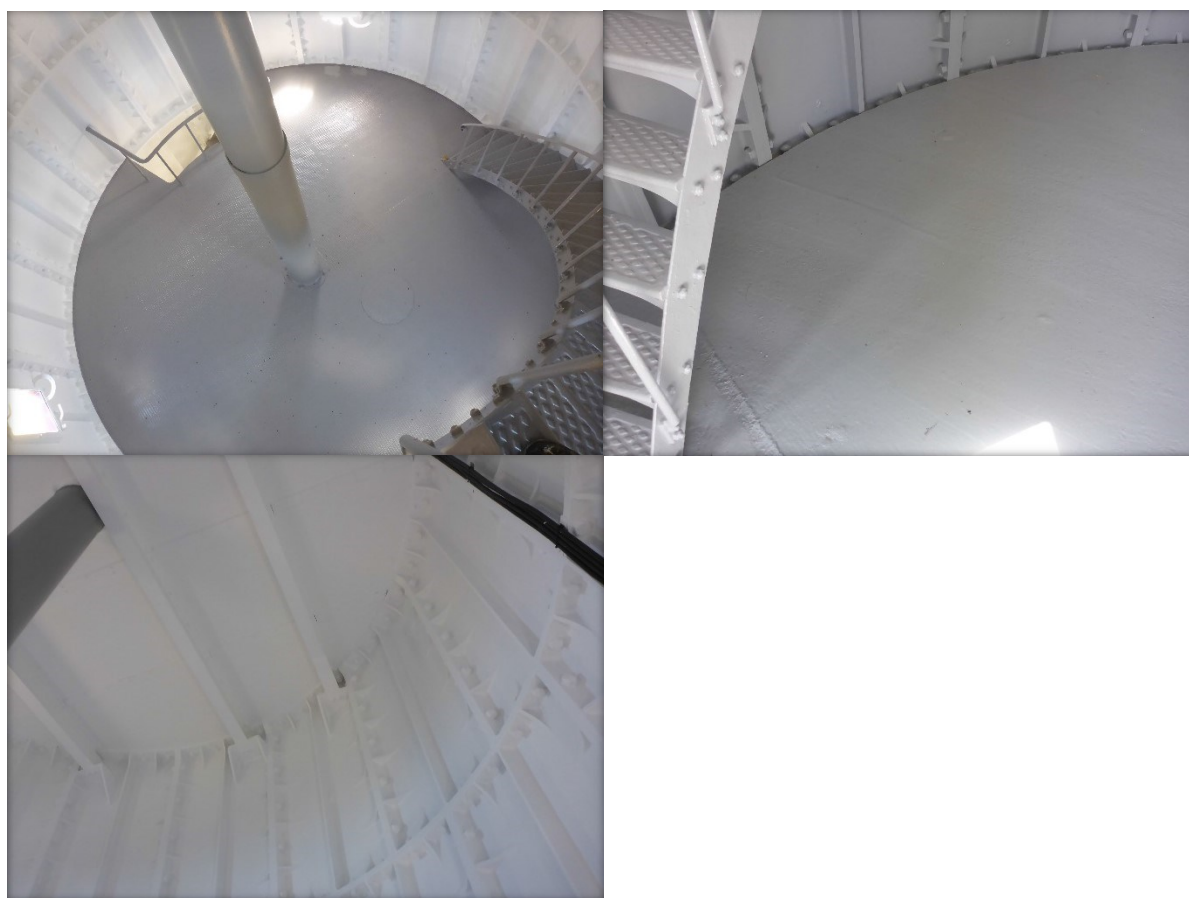
Lighthouse feature: Intermediate floors

The intermediate floors are original parts of a relatively intact twentieth century lighthouse complex (criterion d).

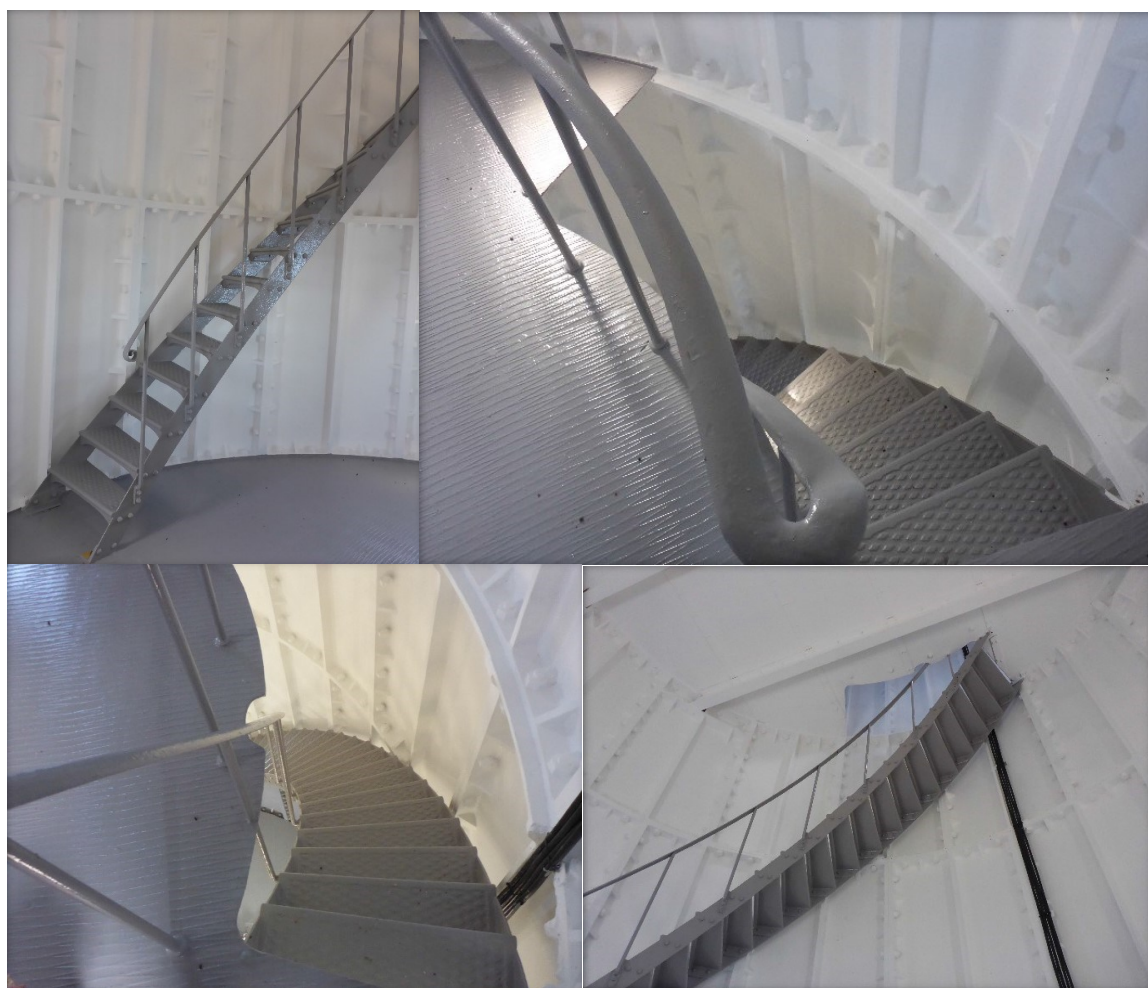
Lighthouse feature: Stairs

The stairs are an original part of a relatively intact twentieth century lighthouse complex (criterion d).

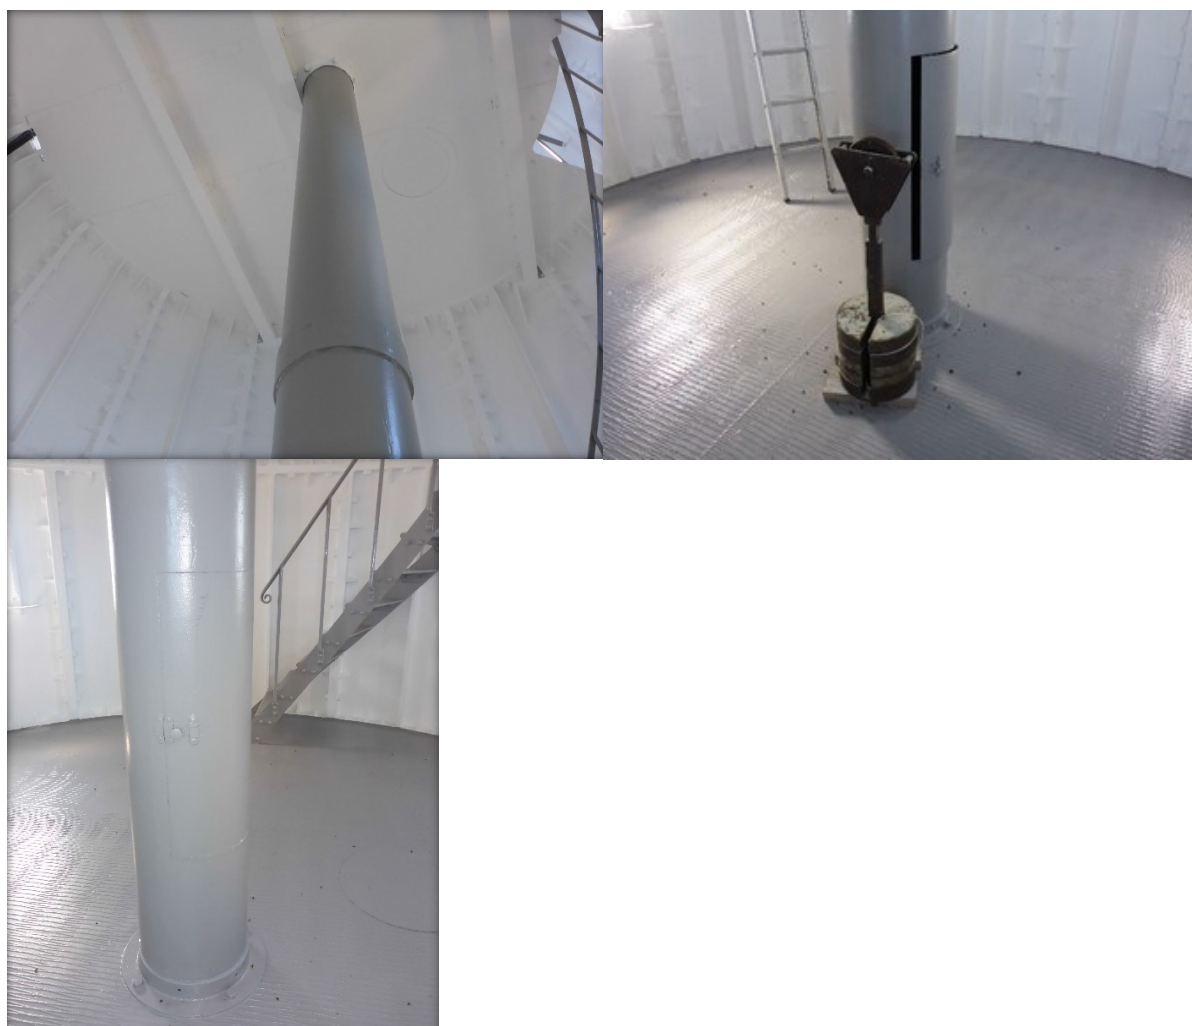
Lighthouse feature: Weight tube

The weight tube is an original part of a relatively intact twentieth century lighthouse complex (criterion d).

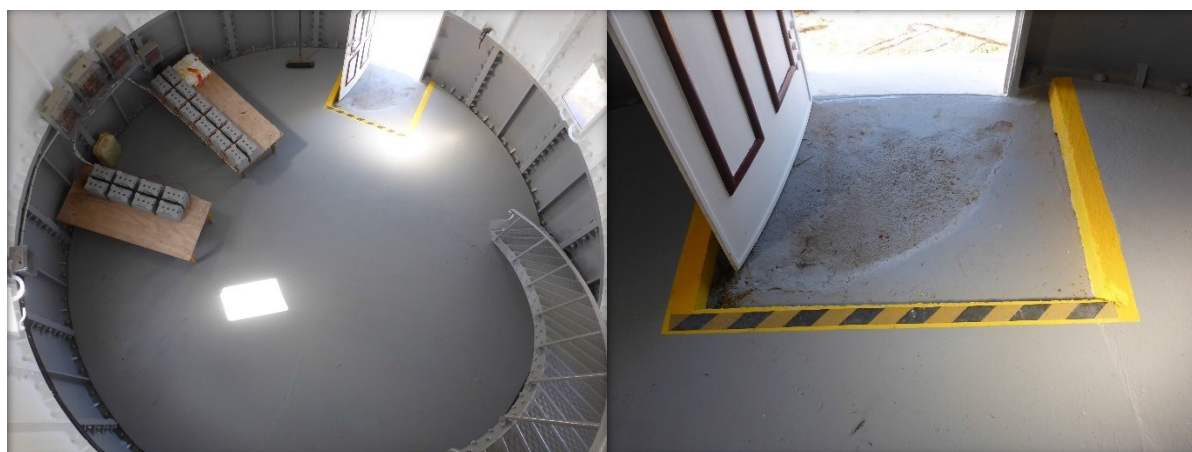
Lighthouse feature: Ground floor

The ground floor is an original part of a relatively intact twentieth century lighthouse complex (criterion d).

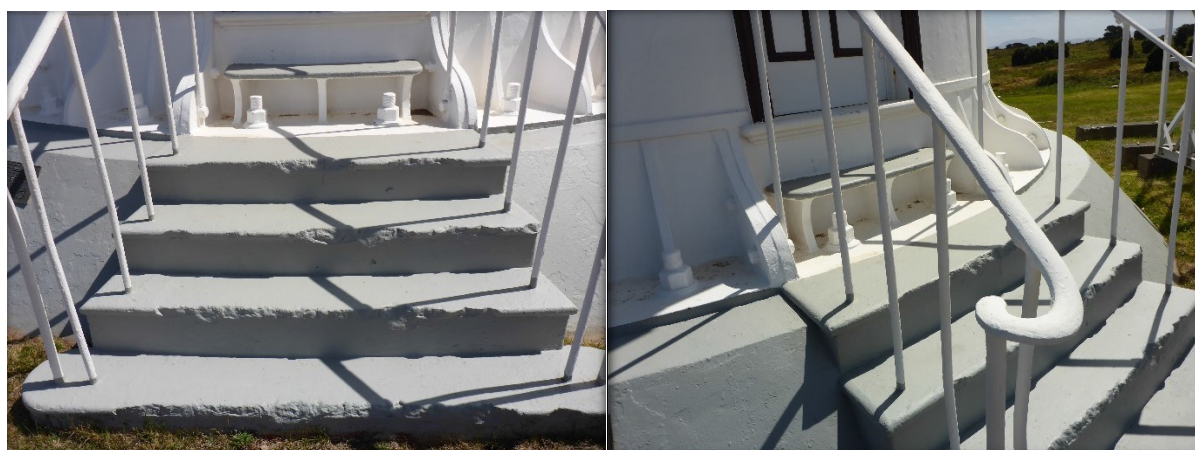
Lighthouse feature: External stair

The external stair is an original part of a relatively intact twentieth century lighthouse complex (criterion d).

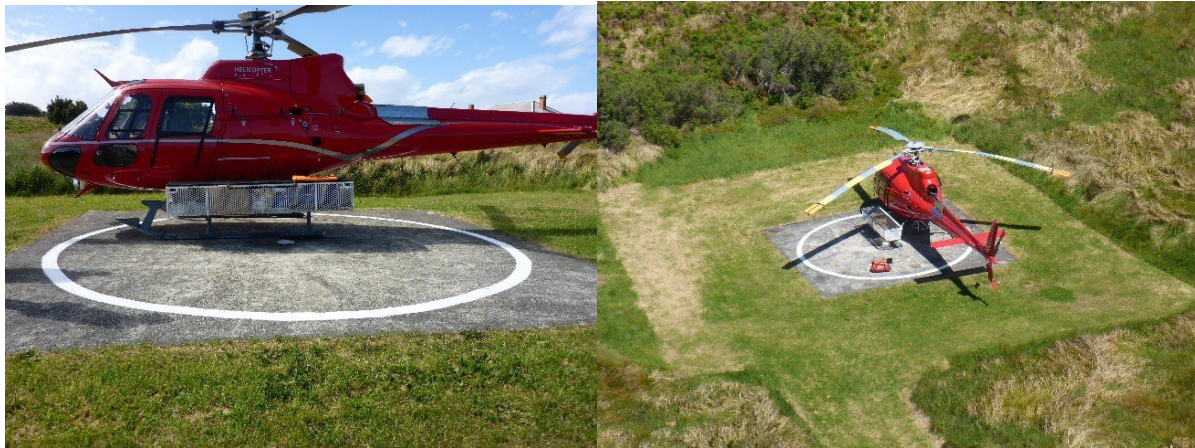
Lighthouse feature: Helipad
