Tasman Island Lighthouse

Heritage Management Plan

2023

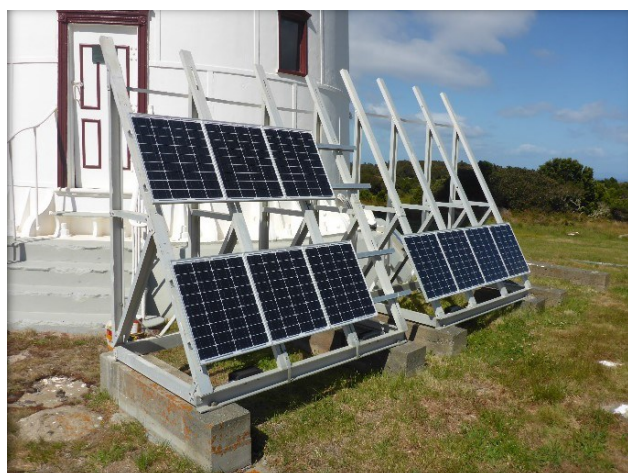
Lighthouse feature: Solar panels

Description and condition

Condition	sound
Integrity	high
Significance	low
Maintenance	keep in service
Rectification works	not assessed

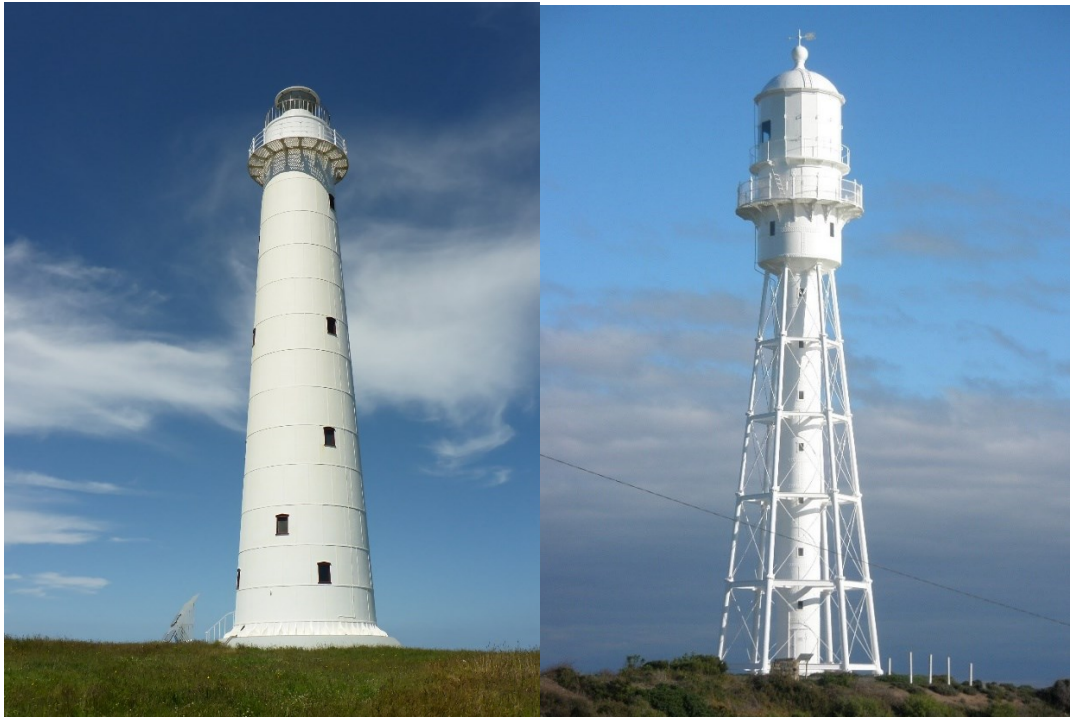
Of all the lighthouses built in Tasmania, the only two constructed of pre-fabricated cast iron were Tasman Island Lighthouse and Currie Harbour Lighthouse located on King Island within Bass Strait. Built in 1879, Currie Harbour Lighthouse arrived from England in 312 pieces of pre-fabricated cast iron that were then assembled on-site. Both lighthouses sport open lattice balconies supported on angle brackets. Unlike Tasman Island, Currie Island retained its original Chance Bros. lantern house.

Figure 19. Currie Harbour Lighthouse, first lit 1879 (©AMSA, 2009)

- Figure 17. Winch shed at Tasman Island, reclad by Parks & Wildlife Service Tasmania (© Brett Hall, 2019)
- Figure 18. Tasman Island Lighthouse, first lit 1906 (© AMSA, 2021)
